Technical Service Bulletin

REAR MOUNT CAMERA IMAGE NOT CLEAR/NO IMAGE ON SCREEN

Bulletin No.: 09-031/20

2014-2018 Mazda3 5-door HB 2016-2019 CX-3

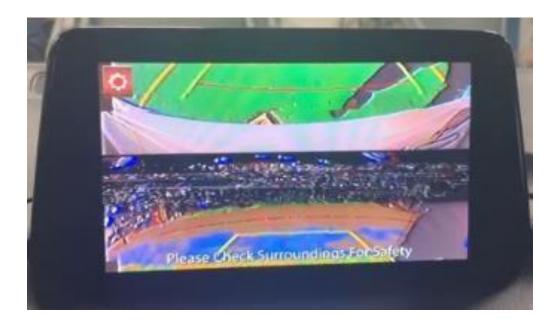
Some vehicles may exhibit a distorted image or no image from the rear mount camera when shifted into reverse. Due to friction, the coating of camera socket terminals may wear out, creating high electrical resistance.

NOTE: The icons and the messages are displayed normally.

Customers having this concern should have their vehicle repaired using the following repair procedure.
