Subject: INTERFERENCE BETWEEN LIFTGATE AND REAR BUMPER	Bulletin No.: 09-032/20
	Last Issued: 09/25/2020

2019-2021 Mazda3 5-door HB (Japan built) with VINS lower than JM1BP*****300046 (produced before June 17, 2020)

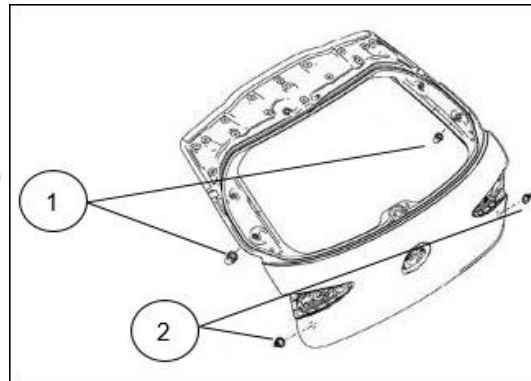
Some vehicles may exhibit that the liftgate interferes with the rear bumper when closed forcefully, resulting in damaged paint on the rear bumper. Due to variations of the clearance between the liftgate and the rear bumper, the bottom edge of the liftgate may overrun the rear bumper. To correct this concern, the hardness of stop rubbers on the liftgate has been modified.

- (1) Rubber, Stop (Main)
(2) Rubber, Stop (Sub)

1. Verify customer concern.
2. Replace the stop rubbers with modified ones.

By changing to the harder rubber, the overrun allowance between the liftgate and the weatherstrip will be reduced and the interference will be prevented. As a result, the bounce when opening the liftgate will be stronger and the liftgate will need to be closed a little harder against the stop rubber. The bounce and tightness of closing the liftgate will be reduced gradually as time goes by.
