Subject: SBS/SCBS WARNING LIGHT ON WITH DTC U0420:68	Bulletin No.: 15-003/20
	Last Issued: 09/04/2020

APPLICABLE MODEL(S)/VINS

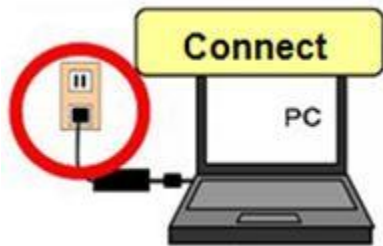
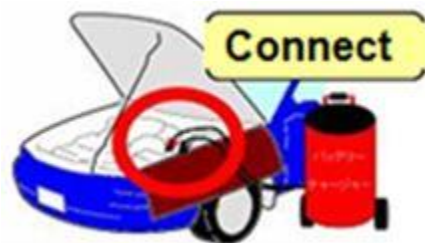
- Make sure that the following connections are firmly connected:
 - Between the vehicle-side connector and the DLC cable
 - Between the PC-side connector and USB port of PC
- DO NOT touch the VCM and DLC cable to prevent noise and a poor connection.
- Connect the AC adapter to the PC in order to stabilize voltage fluctuation during reprogramming. DO NOT use the vehicle battery outlet as a power source for the PC.

- During reprogramming, connect a battery charger to the vehicle with the charge current maintained within 10 to 15A to stabilize voltage fluctuation.

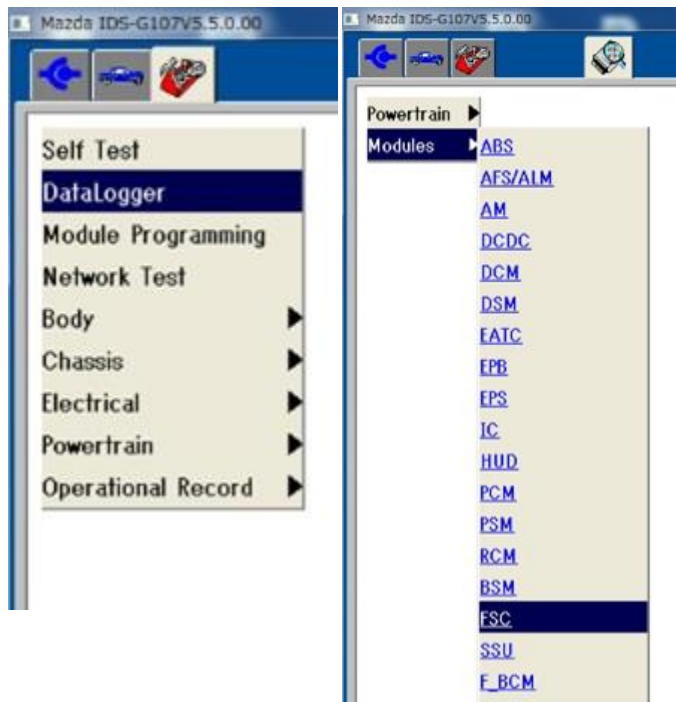
- If the FSC is hot (60 °C [140 °F] or higher), cool it down, otherwise the FSC reprogramming process may fail.

- Turning off the engine will help to cool down the FSC.
- The FSC temperature can be monitored by the data logger function of the Mazda Modular Diagnostic System (M-MDS).

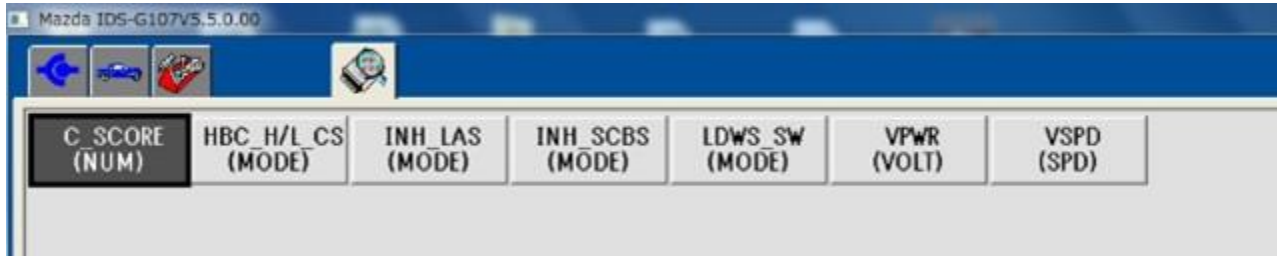
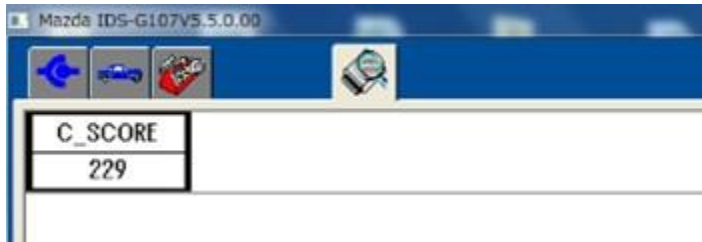
The C_SCORE indicates the FSC temperature. As the temperature rises, the value of C_SCORE decreases, therefore "C_SCORE" must be **174 or higher** to perform the FSC reprogramming.

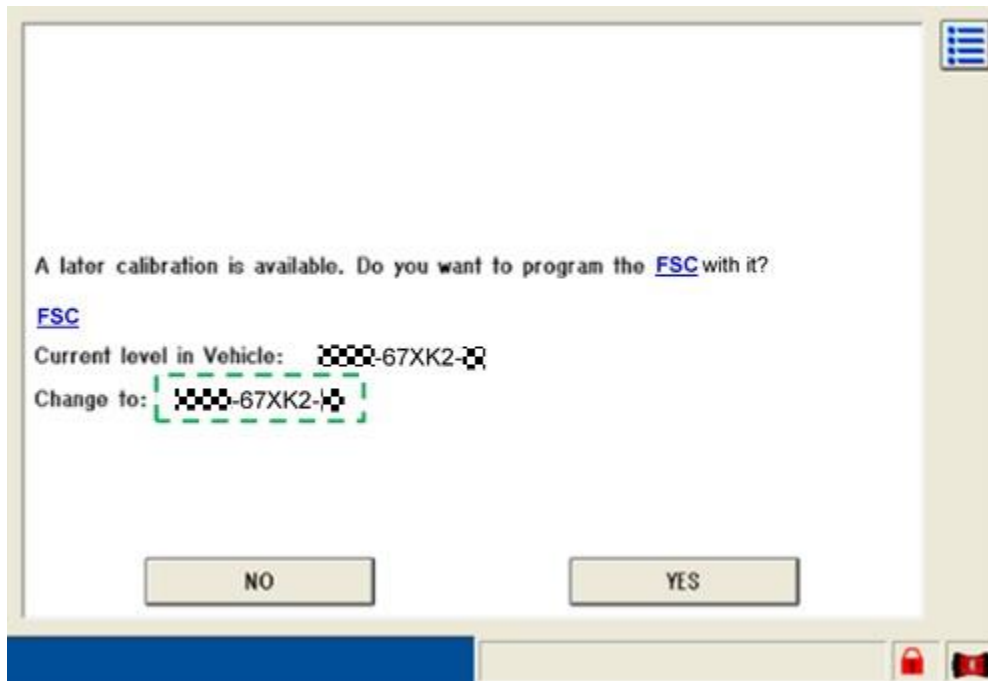
- If the message “No later calibration is available on the system for this FSC” is displayed, the FSC is already at the latest calibration and this Service Information does not apply. “Current level in Vehicle” will show the new file name.

3. The following screen will be displayed: Click 'YES' and follow the M-MDS instructions to reprogram the FSC.
