## SERVICE INFORMATION BULLETIN

**APPLICABILITY:** 2020MY Legacy & Outback **NUMBER:** 15-273-20  
**SUBJECT:** Denso CP1 BASE (Dual 7" Display Screen) **DATE:** 09/09/20  
 Erratic Operation

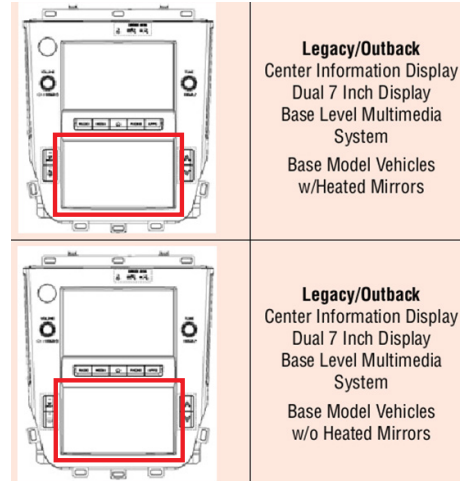
This Service Information Bulletin addresses isolated customer concerns regarding the pictured CP1 BASE Model Center Information Display (CID) LOWER 7-inch display screen flashing, not responding to touch inputs and / or shutting off intermittently.

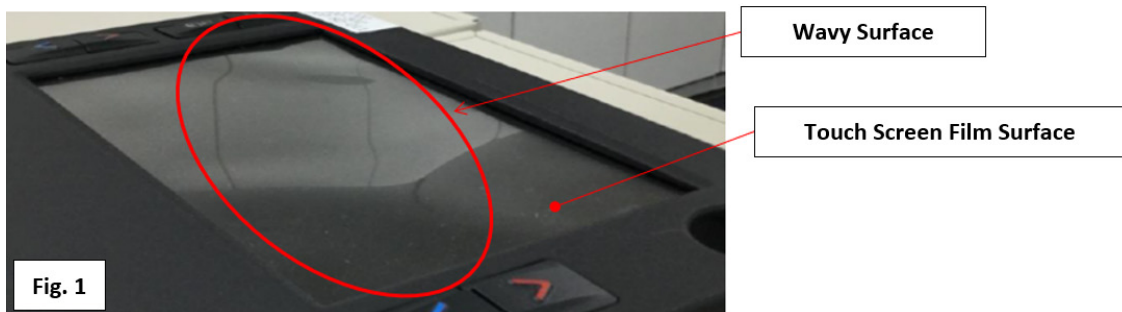
Check for any deformation or waviness of the touch screen surface. Inspect the surface condition diagonally with light reflecting on it at various angles. Is any waviness visible as shown in **Fig. 1** below?

- **If YES:** Replace the CID assembly because the surface of the touch screen is deformed.
- **If NO:** Proceed to **Step 2**.

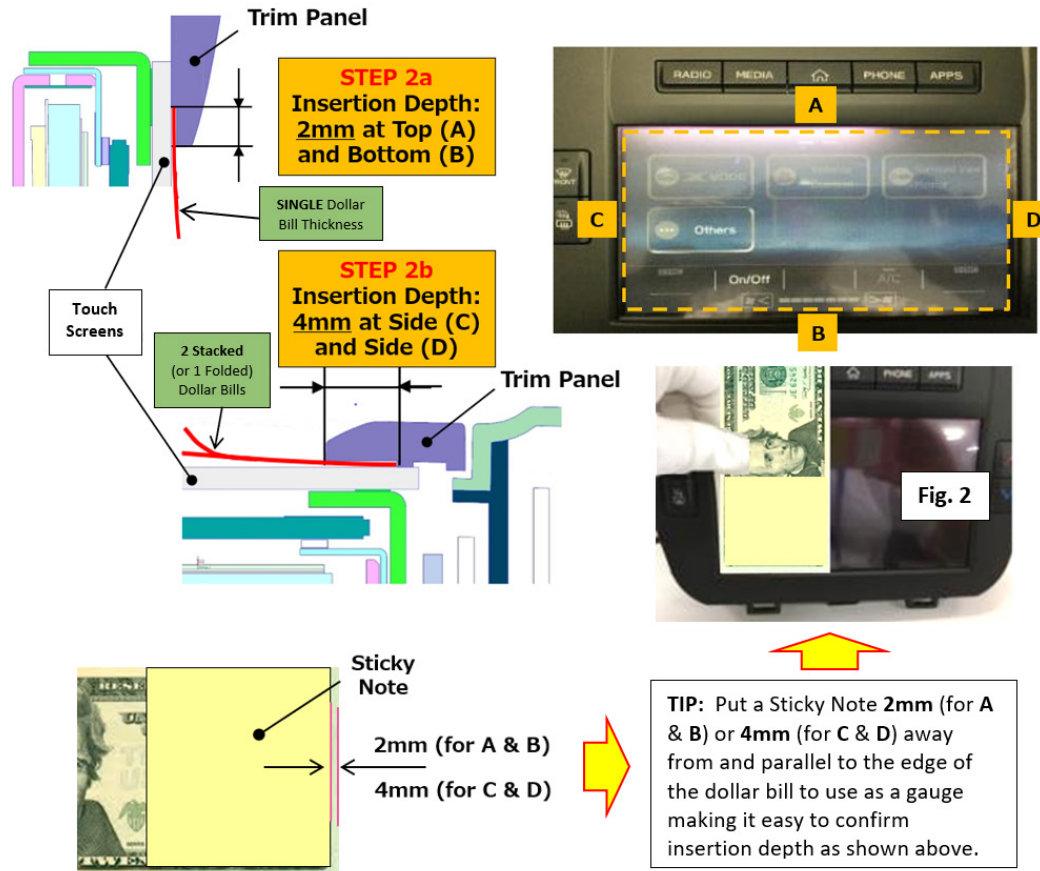
**Steps 2a & 2b:** Inspect for deformation of the lower touch screen, the surrounding trim panel and for any foreign material trapped in between them. Use the illustrations below as a guide.

- **2a:** Insert a (preferably a crisp, new) dollar bill into the gaps between the touch screen and the surrounding trim panel along the top (**A**) and bottom (**B**) as shown in the **Fig. 2** example below. The dollar bill should be able to be inserted **2mm** into the full width of both the top and bottom gaps.
- **2b:** Insert a dollar bill folded in half (to provide 2 thicknesses) into the gaps between the touch screen and the surrounding trim panel along the sides (**C**) & (**D**). The folded dollar bill should be able to be inserted **4mm** into the side gaps from top to bottom.

- If the dollar bill can be inserted into the gap **2mm** on the **Top** and **Bottom** and **4mm** on **BOTH** sides, there is no deformation of the touch screen or surrounding trim panel. Proceed to **Step 4**.
- If the dollar bill cannot be inserted, replace the CID because the surrounding trim panel and / or touch screen are likely deformed.
