**SERVICE BULLETIN**

**APPLICABILITY:** 2020MY Legacy and Outback Models      **NUMBER:** 15-261-20R  
**SUBJECT:** Reprogramming File Availability for Optimization of Gen 4 Denso CP1 Infotainment Systems      **DATE:** 03/10/20  
**REVISED:** 09/09/20

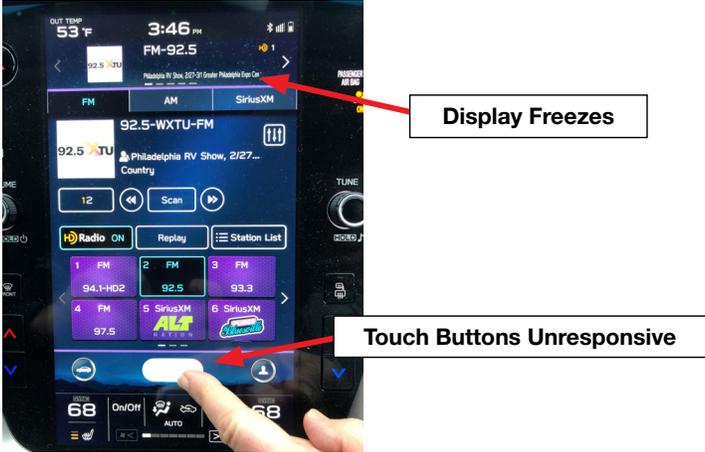
Symptom #	Description of Symptom:
<b>1</b>	<p>The CP1 display and/or center Combination Meter display freezes. No response from touch screen or voice guidance. After switching the ignition off and opening the driver’s door, the system does not recover**.</p> <div style="text-align: center;">

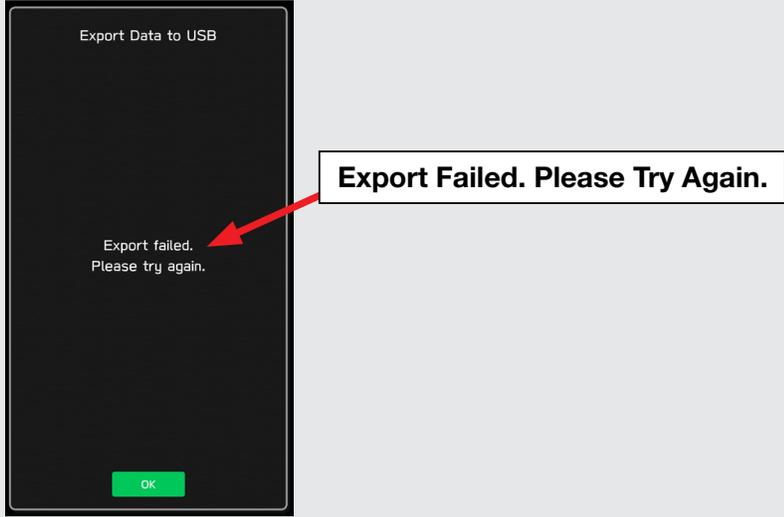
Symptom #	Description of Symptom:
4	<p>Diagnostics Recorder Data cannot be exported to the USB memory device. When the diagnostic log data is being downloaded (by selecting: Dealership Menu &gt; Diagnostics Recorder &gt; Export Data to USB), it fails after the progress bar reaches almost 90% with an error message of Export failed. Please try again.</p>

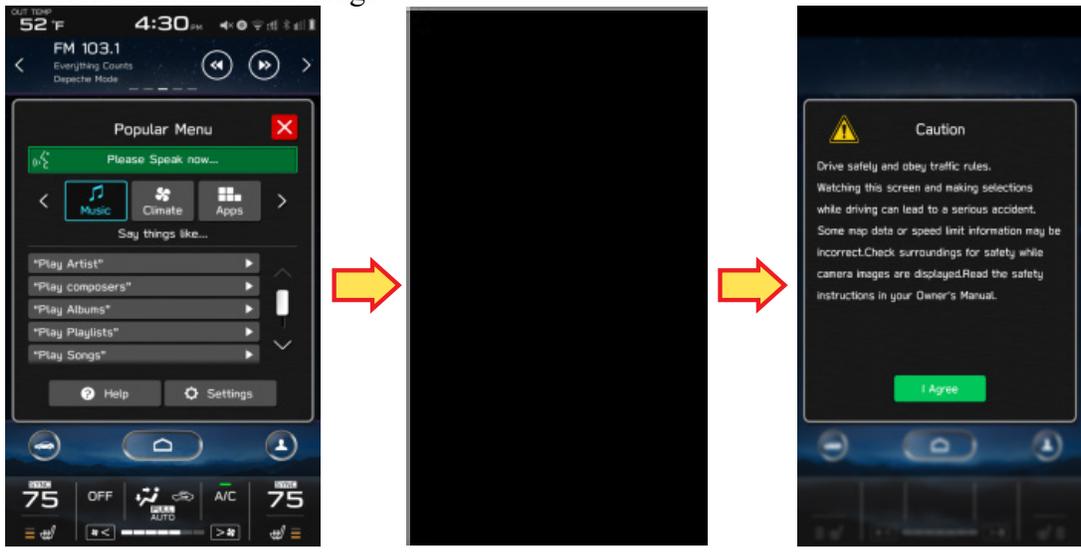
5	<p>When using Voice Recognition to search for a 'Nearby POI' (Point of Interest) in Canada with FRENCH language selected, the CP1 display turns black and displays a Caution / disclaimer message.</p>

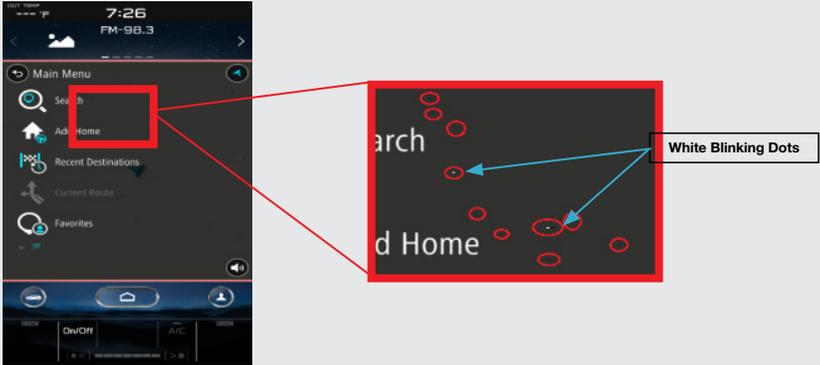
Symptom #	Description of Symptom:
1	Several minutes after Engine start, the Center Information Display (CID) reboots.
2	After an extended period of usage, some white blinking dots appear on the display.

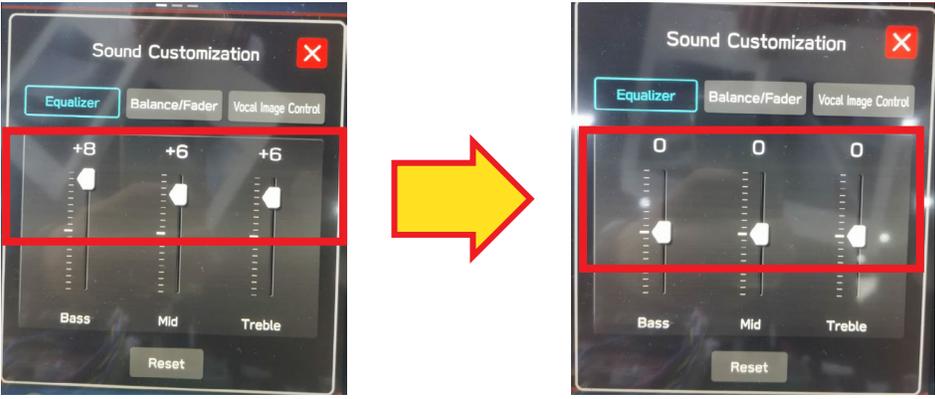
7	Customer-selected Equalizer settings are lost. Equalizer returns to the default settings after ignition switch is turned OFF and back ON.

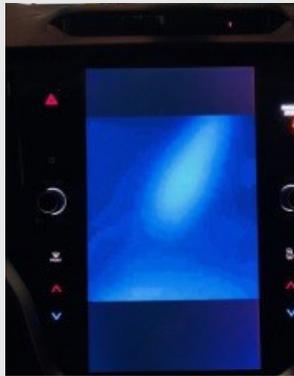
Symptom #	Description of Symptom:
9	In a case where the system was shut down while the Navigation map screen was being displayed, the display goes blank (black screen) soon after the Disclaimer screen is displayed after restarting.
10	CID reboots repeatedly after setting a destination using the Navigation system.
11	CID reboots while using the Pandora application via CarPlay.
12	Bluetooth connection cannot be reestablished when using certain smart phones. When using Android Auto on certain smartphones, a Bluetooth connection cannot be reestablished automatically once it has been disconnected.
13	CarPlay connection cannot be established. When connecting an iPhone via USB, "CarPlay Unavailable" is displayed and CarPlay does work.
14	The HOME screen goes blank. When the screen is switched from Camera mode to HOME, no icons are displayed as shown below.
