<b>Subject:</b>  <b>CONTROL UNIT SOFTWARE UPDATE CAUTION</b>	<b>Service Alert No.:</b> SA-066/20
	<b>Last Issued:</b> 09/14/2020

2019-2021 Mazda3  
2020-2021 CX-30  
2021 CX-5  
2021 CX-9

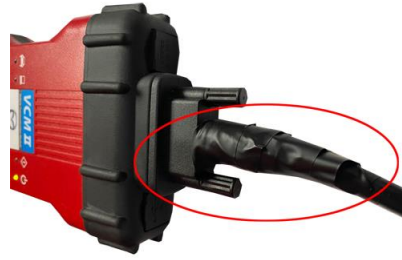
Examples of M-MDS VCM cables in poor condition	
DLC connector damaged

VCM DLC cable taped

Available on e-Store #F00K-10-8663

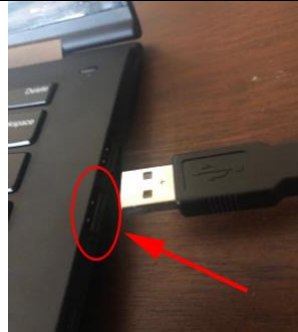
Computer USB port and/or USB cable worn/damaged

USB cable available on e-Store #F00K-10-8653  
Computer USB port - Sublet repair
