NUMBER: 12-297-20

SERVICE BULLETIN

SUBJECT: Rear Seat Folding Arm Rest- Design Change

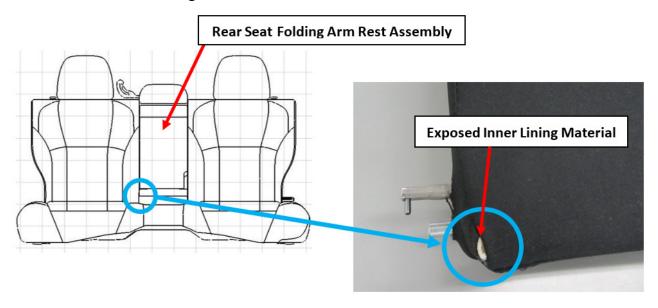
This bulletin announces a design change made to the rear seat folding center arm rest. The change is in response to a small number of reports regarding the inner cloth material becoming exposed at the bottom corners near the hinge area as illustrated below.

If the inner cloth material is exposed at the bottom corners near the hinge areas as described above, replace the arm rest assembly following the procedure in the applicable Service Manual.
