**Subject:** The Shyft Group has determined a possible defect in the installation of the instrument panel.

**Condition:** Fasteners may loosen in the dash substructure.

**Applies To:** This bulletin applies to 2020 Aeromaster on the Ford F59 chassis manufactured between January 15, 2020 and August 26, 2020. Contact Utilimaster Warranty Department to verify chassis VIN.

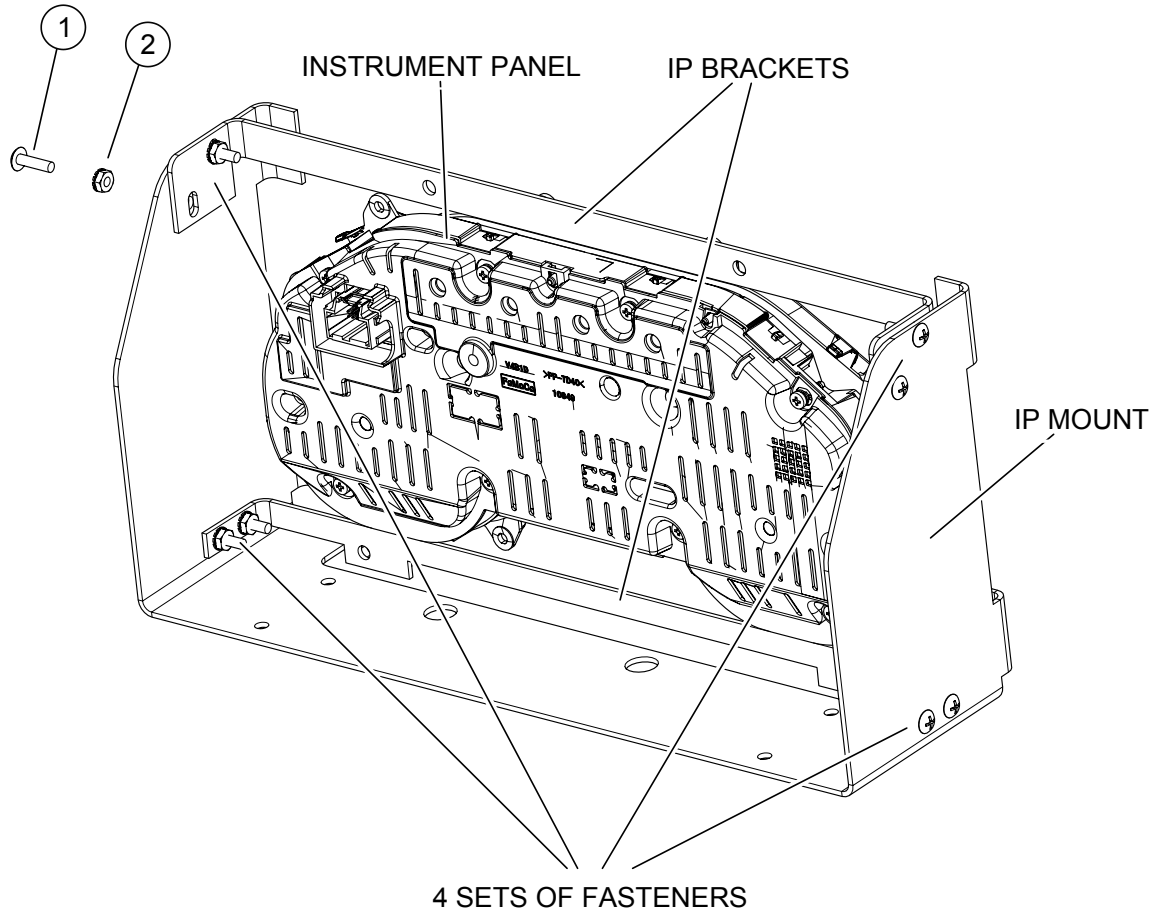
*Instrument panel bracket (dashboard not shown for clarity)*

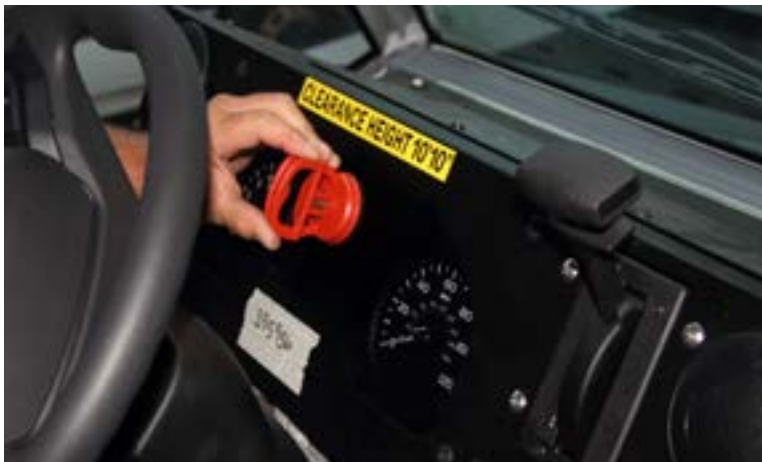
*Suction cup tool*

1. Read and understand all the instructions before starting the repair.
2. Attach suction cup to instrument panel and check for vertical movement. If instrument panel is loose, proceed with repair. If instrument panel is firmly secured, no further action is necessary.

If suction cup is NOT available, press finger tips to dash panel to check for movement.

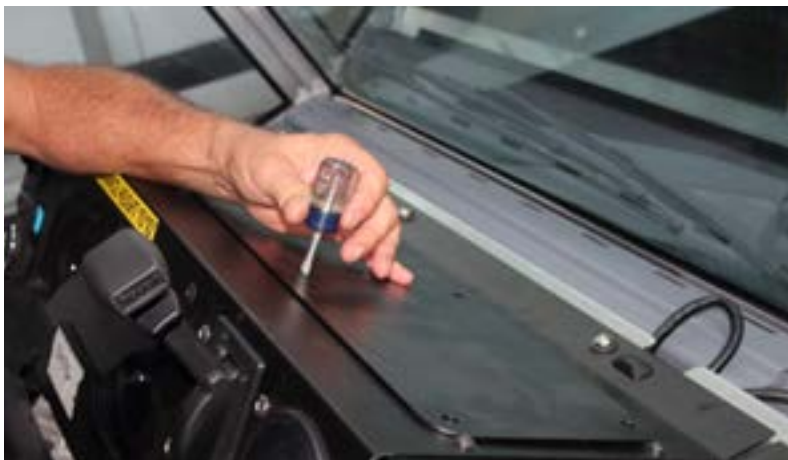
*Dash access panel fasteners*

1. Remove (8) fasteners from dash access panel and set aside.

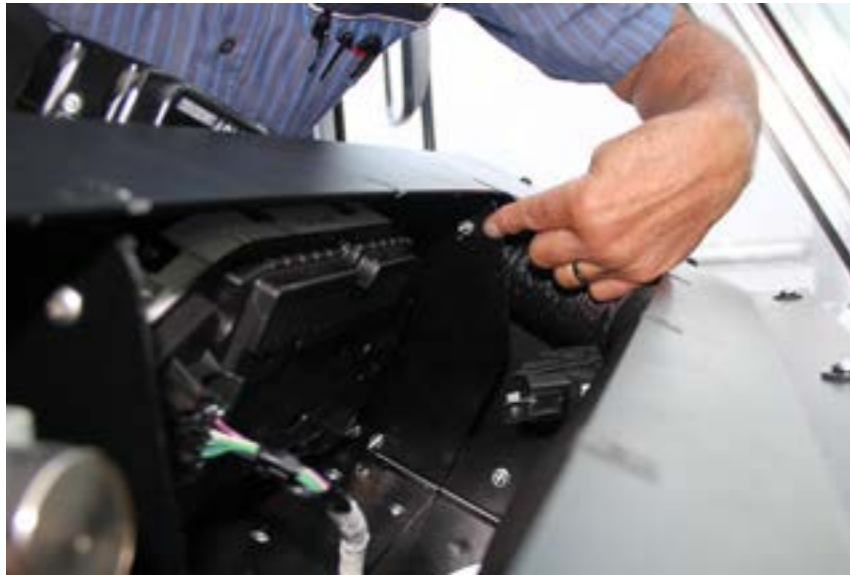
*Top bracket fasteners at instrument panel*

2. Tighten any loose nuts at the top and bottom instrument panel brackets. Replace any missing fasteners.

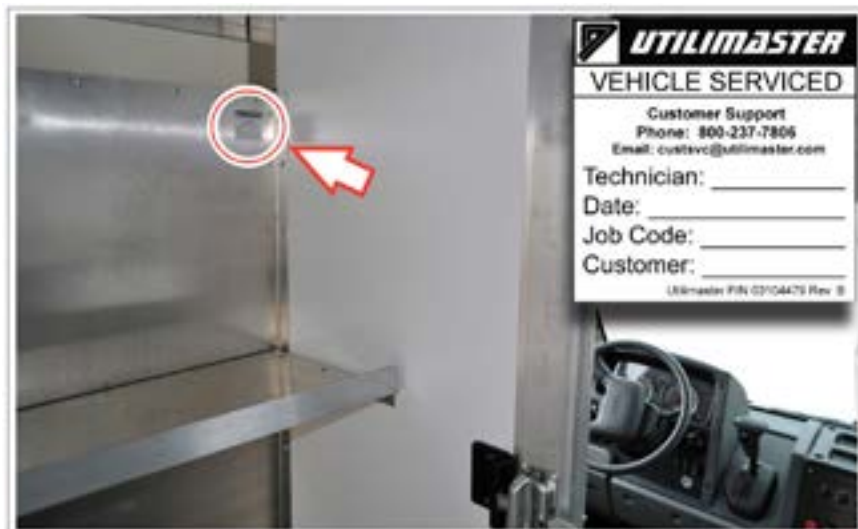
*Service decal on driver's door pocket (cargo side)*

3. Secure all instrument panel fasteners.
4. Secure the dash access cover.
5. Use Job Code 13-AF-22-37-12 from this document to complete the SERVICED decal.
6. Adhere the decal to the upper right-hand corner of the driver's door pocket panel or sidewall next to the bulkhead wall. Do NOT cover any previously applied decals.
