Service Alert

Subject: ENGINE NO START WITH DTC B13D3:97 STORED DUE TO ACTIVATION OF PACEMAKER FUNCTION	Service Alert No.: SA-048/20
	Last Issued: 09/21/2020

2019-2021 Mazda3
2020-2021 CX-30

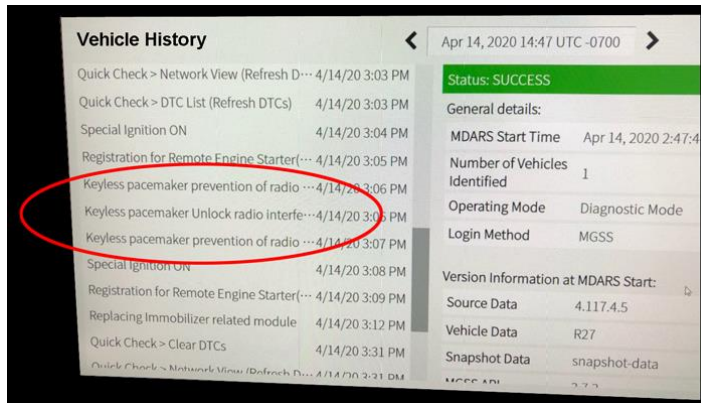
Some customers may experience an engine no start condition where the engine will only start by holding the key transmitter over the Start/Stop button. This may be caused by an accidental activation of the keyless pacemaker function.

Example of Keyless Pacemaker Function activated:

- YES: Deactivate the Keyless Pacemaker Function.
- NO: This service information does not apply. Go to MGSS [DTC B13D3:97 \[BODY CONTROL MODULE \(BCM\)\]](#).
