Vehicles affected: P22 McLaren GT

Location: Electrical - Electrical Systems

Concern: Power Tailgate Warning Message when the vehicle is not equipped with one

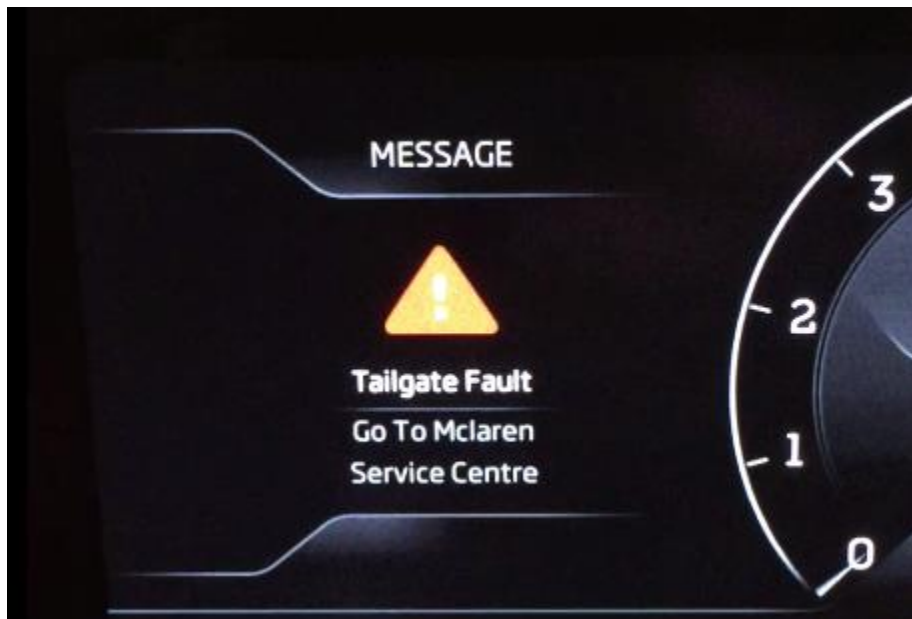
It has been identified that a small number of vehicles have been fitted with a PTCU module when the vehicle was ordered without this option. This will result in a warning message in the vehicle's IC when the tailgate button inside the cabin of the vehicle is pressed.

Please confirm that the vehicle was ordered without a power tailgate. If that is the case, to address this issue the technician is required to unplug and physically remove the PTCU module from the vehicle. The removal of the module is necessary for avoiding unintended re-connection of the module if any future work is carried out in that area.
