Vehicles affected: P15R: Senna GTR

Location: Body Exterior

Concern: Air jacks leaking

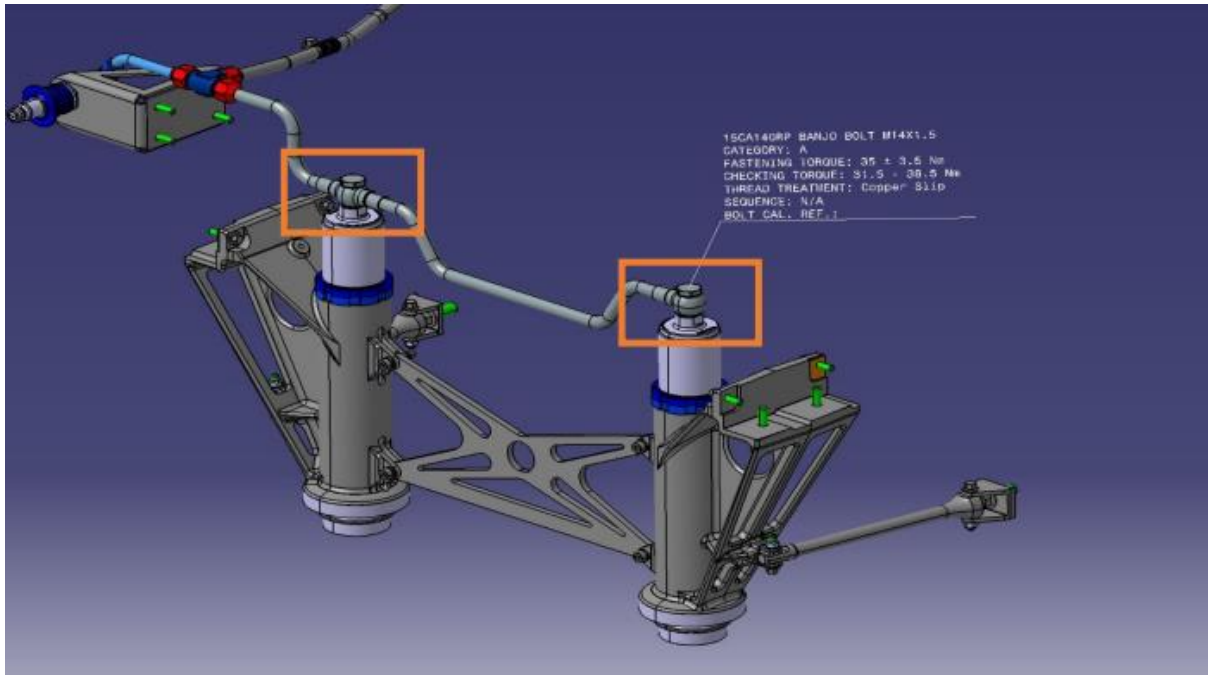
Correct copper grease application:

Only apply copper grease on the thread of the bolt

Correct torque setting:

Banjo bolt: 15CA140RP M14x1.5 @ 35NM
