JLRTB02052NAS1
TECHNICAL BULLETIN
16 SEP 2020

Rear Doors Difficult To Open

MODEL:	MODEL YEAR:	VIN:	ASSEMBLY PLANT:	APPLICABILITY:
Defender (LE)	2020 Onwards	000431 Onwards	Nitra (Slovakia)	5-Door

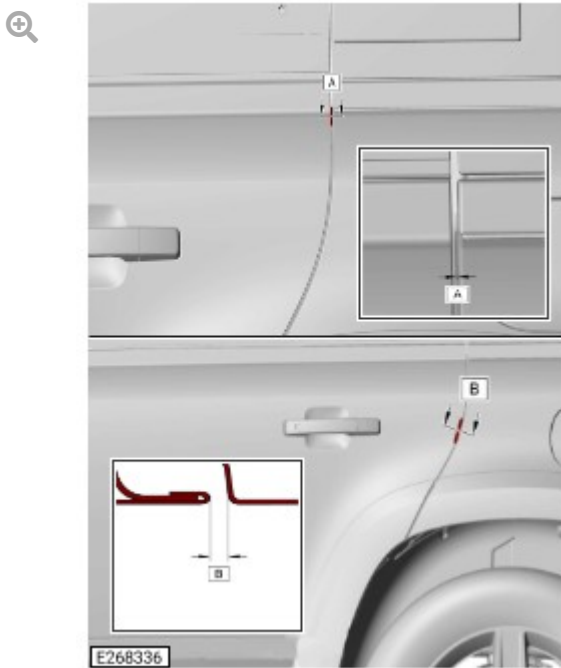
Check the alignment of the rear door(s) in the areas shown in the illustration.

SECTION	DESCRIPTION	GAP	PROFILE
A	Rear door to rear quarter	N/A	0.0 ± 0.5 mm
B	Rear door to rear quarter	3.5 ± 0.7 mm	0.0 ± 0.7 mm

Adjust the rear door(s) to be within tolerance (see TOPIx Workshop Manual section 501-26: Body Repairs: Vehicle Specific Information and Tolerance Checks - General Procedures - Rear Door Alignment).

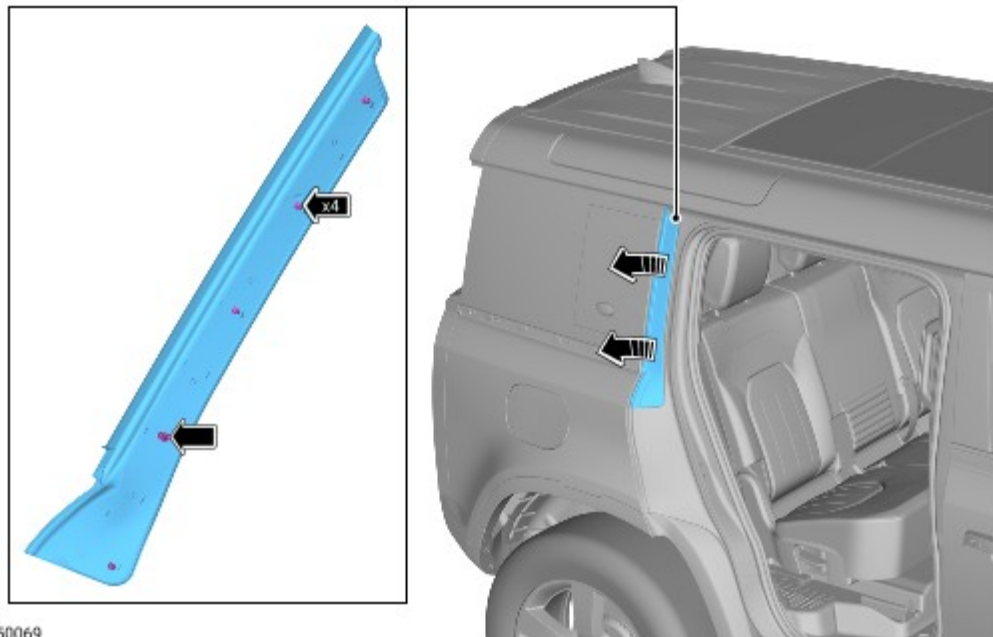
E250069

C-pillar exterior finisher trim to rear quarter window alignment incorrect.

Remove and discard the C-pillar exterior finisher trim.

- ■ Clean the area behind the C-pillar exterior finisher trim.

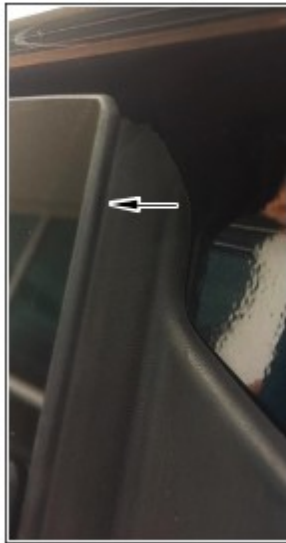
E268337

- ■ Remove the adhesive tape backing.
 - ■ **Make sure the C-pillar exterior finisher trim protrudes 1-1.5 mm away from the rear quarter window, as shown in the illustration, before fully securing.** The image with the **RED 'X'** shows the C-pillar exterior finisher trim installed incorrectly behind the rear quarter window. The image with the **GREEN '✓'** shows the C-pillar exterior finisher trim installed correctly with a 1-1.5 mm protrusion from the rear quarter window.
-

Install the new C-pillar exterior finisher trim.
