JLRTB02055NAS1

**TECHNICAL BULLETIN**

Non Start In Cold Ambient Temperatures

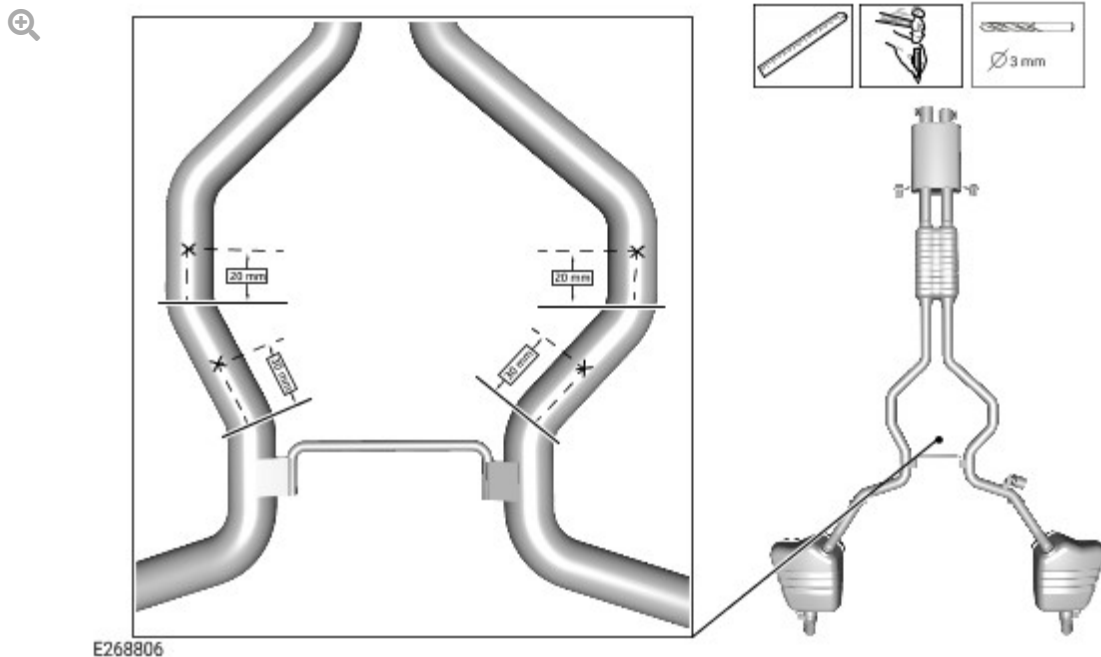
2.

The vehicle will not start after being left over night in cold ambient air temperatures. Further investigation has found high levels of frozen liquid blocking the exhaust system.

Water vapor formation, as a result of normal combustion, is being condensed and frozen over time.

Use a suitable tool to measure each drilling position, shown in the illustration.

- ■ Use a center punch to mark each exact drilling position.
- ■ Slowly drill a 3 mm hole in each position and dispose of any metal filings.
- ■ Allow any liquid to drain out of the exhaust system.
- ■ Use a suitable tool to remove any sharp edges.
