# NEW DEFENDER - RAISED AIR INTAKE FASTENERS MISSING

NAS20.09.001

AFTERSALES BULLETIN

SEPTEMBER 3, 2020

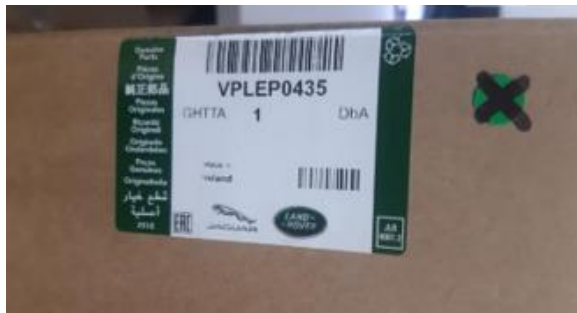
### Re-worked ('X' over green dot)

Please be advised that a number of Air Intake Kits (VPLEP0435) for New Defender vehicles may not contain the correct quantity of fasteners. Kits have been reworked, but a small number may have been sent to retailers before this issue was identified. Reworked kits will have an 'X' on the green dot, while non-reworked kits will not.

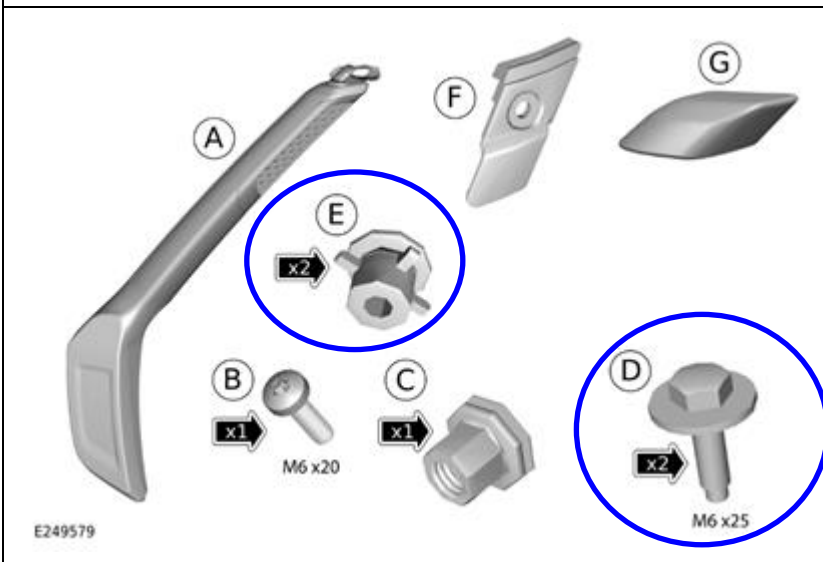
### Kit Contents (required):

**D - Screw M6x25 (2 required)**  
LR132825 or T2H42792

**E - Jack Nut M6x20 (2 required)**  
ZKC2228 or T2R11411

If any kit has an incorrect quantity of fasteners 'D' and/or 'E', use the Land Rover or Jaguar part numbers indicated above for kit installation. Contact the customer support team with the original order number and a photo of the kit box with the green dot visible. A credit for the missing components will be processed.
