TECHNICAL TOPICS ELECTRICAL

L551 Flickering Screen

20MY RR Evoque

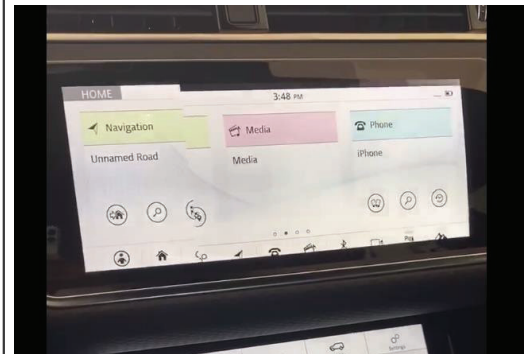
- Upper and/or Lower screen behaves erratically: glitching, flickering, or scrolling.

- A software calibration change was released in 20B1, some vehicles continue to exhibit erratic behavior.

- For any issues that are discovered post 20B1 please submit a TA or EPQR with photos of the failure mode and the IMC is already at 20B1.
- Affected vehicles will need a TA raised first.
- Replace the APIX cable with L560 cable and a CCF change to match new cable length.
- It is extremely important that we document the repair in a TA to prevent future repairs reverting the APIX cable back to a L551 cable until the SSM/TSB is released.
