**Location:** Powertrain Systems - HVAC

**Topic:** Water ingress into the passenger or driver foot area

**Condition:** Mainly when HVAC system is in operation

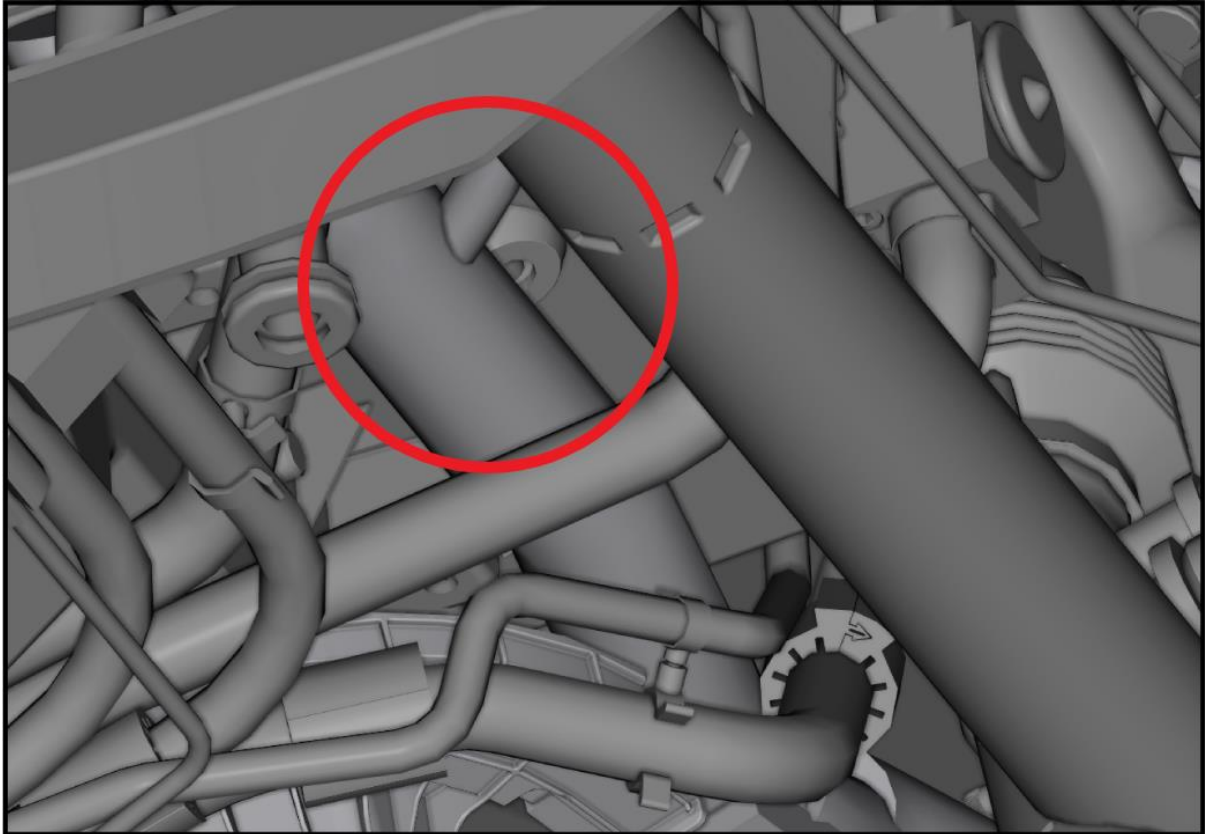
Figure 1: HVAC Drain Tube Still

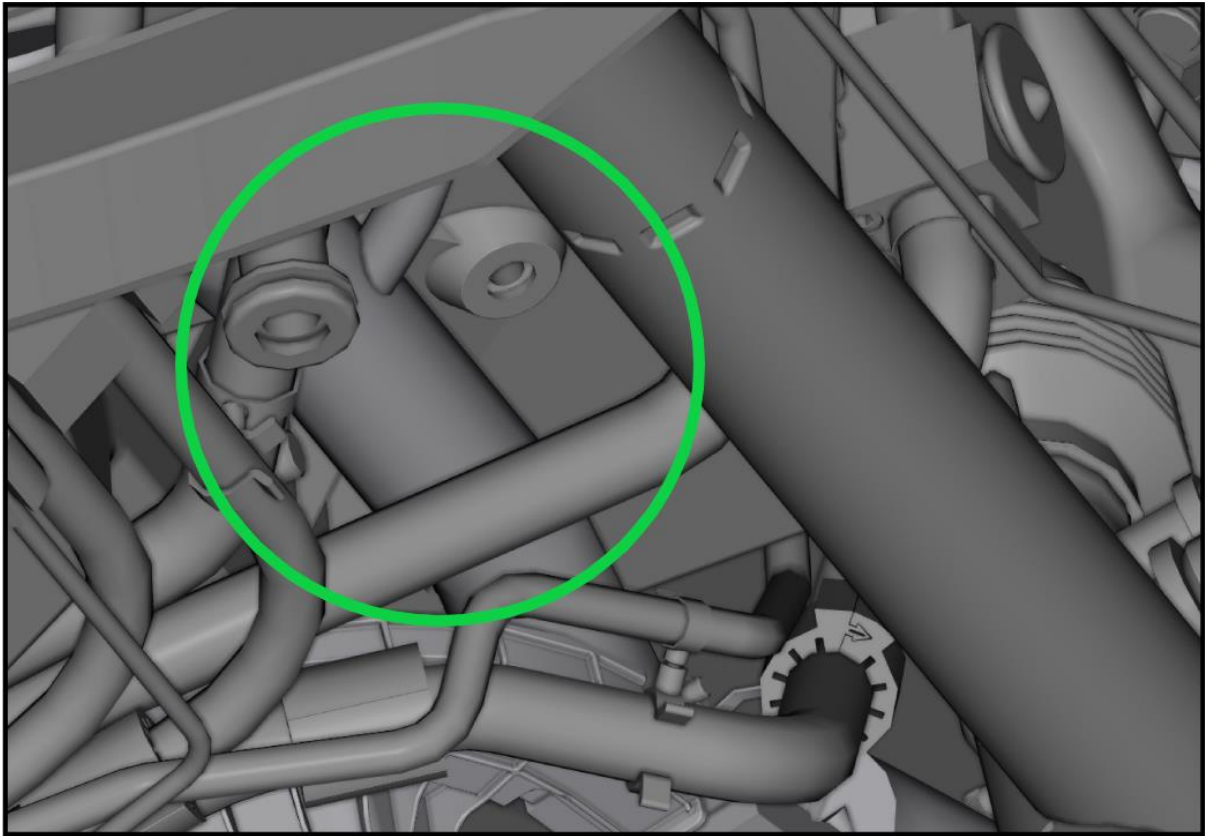
If it is found to be blocking the HVAC drain, the water may be redirected into the vehicle's cabin.

Figure 2: Body Harness Blocking

HVAC Drain

Re-position the electrical body wiring harness to allow the water to freely flow from the HVAC drain and re-secure the electrical body wiring harness.
