TECHNICAL TOPICS

Front Door Window Operation

20MY Range Rover

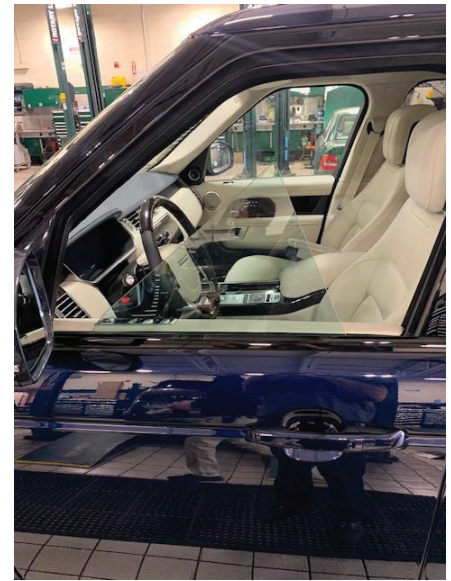
- A limited number of vehicles may have been built with the front door window glass not properly installed into the locking clips in the window regulator.

- The concern has been addressed in production.
- For any unsold vehicle built before LG-594956 please check the window operation at PDI.
- Position the window halfway down and try to pull the glass upward by hand near the rear of the door. If the glass lifts it is not locked into the window regulator properly, please ensure that the glass is clipped in properly by first sliding it rearward into the rear window run seal and then downward into the regulator.
