# Technical product information

<b>Topic</b>	New Continental GT, GTC and Flying Spur - Suspension Warning Lamp
<b>Market area</b>	Bentley: worldwide (2WBE)
<b>Brand</b>	Bentley
<b>Transaction No.</b>	2059172/4
<b>Level</b>	EH
<b>Status</b>	Approval
<b>Release date</b>

## New Continental GT, GTC and Flying Spur - Suspension Warning Lamp

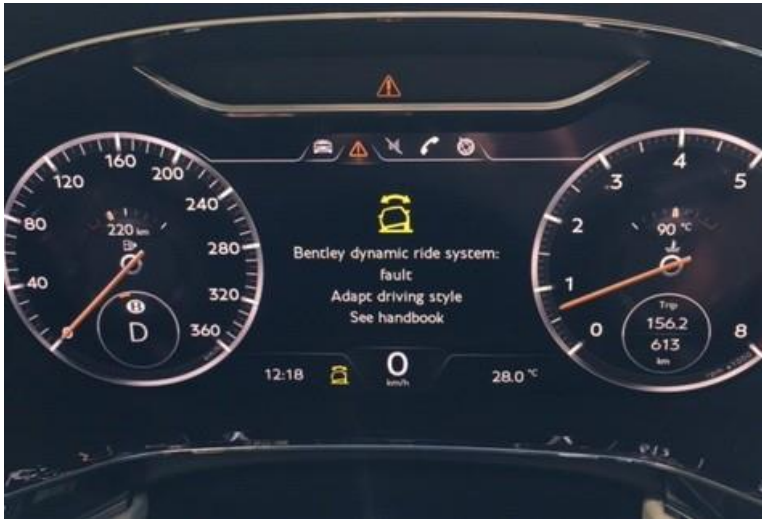
Suspension warning lamp illuminated on Driver Instrument Panel (DIP).

“Bentley dynamic ride system: *fault - Adapt driving style - See handbook*” displayed on DIP.

Red or yellow Suspension warning lamp illuminated on DIP.

Diagnostic Trouble Code (DTC) *U005600: Vehicle communication BUS D performance, Symptoms 12689537, 12689541 or 12689542* stored within address's *0074 - Chassis Control, 00D4 – Roll Control System 1 or 00D5 – Roll Control System 2*.
