Model: Dorsoduro 900 - Shiver 900 (all versions)

Subject: release of new instrument cluster software to resolve new key matching failure issue

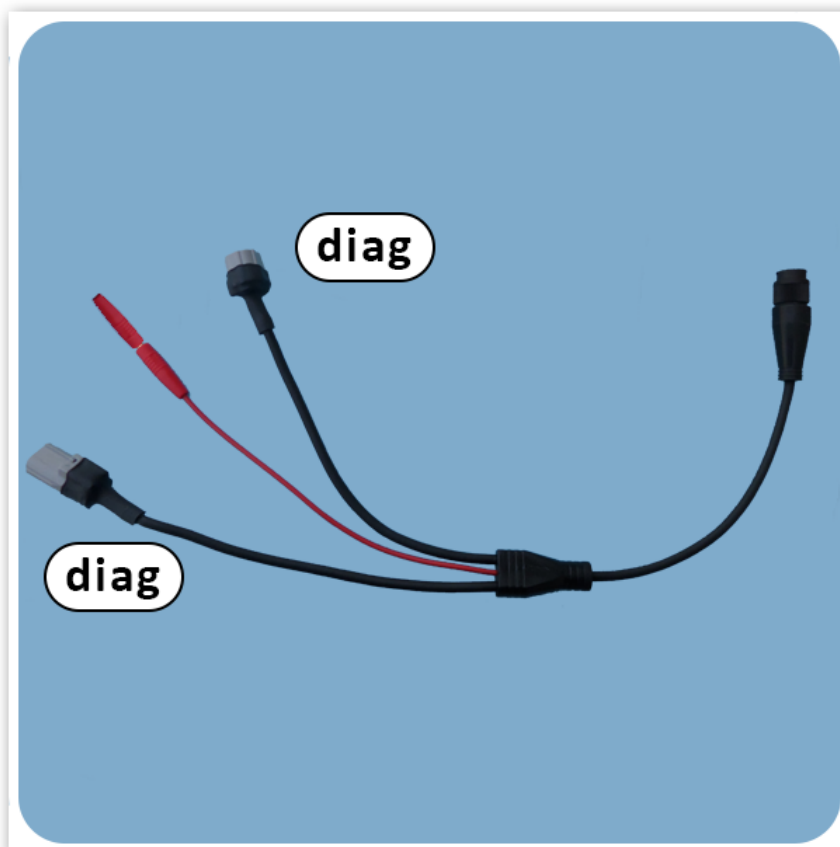
Photo 1 (A-MP interface cable, P/N 021011Y)

The A-MP interface cable, **P/N 021011Y** (see photo 1), which is purchasable as an accessory for the P.A.D.S., is required to update the instrument cluster software of the aforementioned model.

DO NOT CONNECT the red power feed wire. This wire must be insulated only to prevent the danger of short circuiting.
