# HYUNDAI Technical Service Bulletin

| GROUP<br><b>STEERING</b> | NUMBER<br><b>20-ST-002H-2</b> |
| DATE<br><b>SEPTEMBER, 2020</b> | MODEL(S)<br><b>ELANTRA (ADa)</b> |

**SUBJECT:** C-MDPS WORM SHAFT ASSEMBLY BEARING NOISE

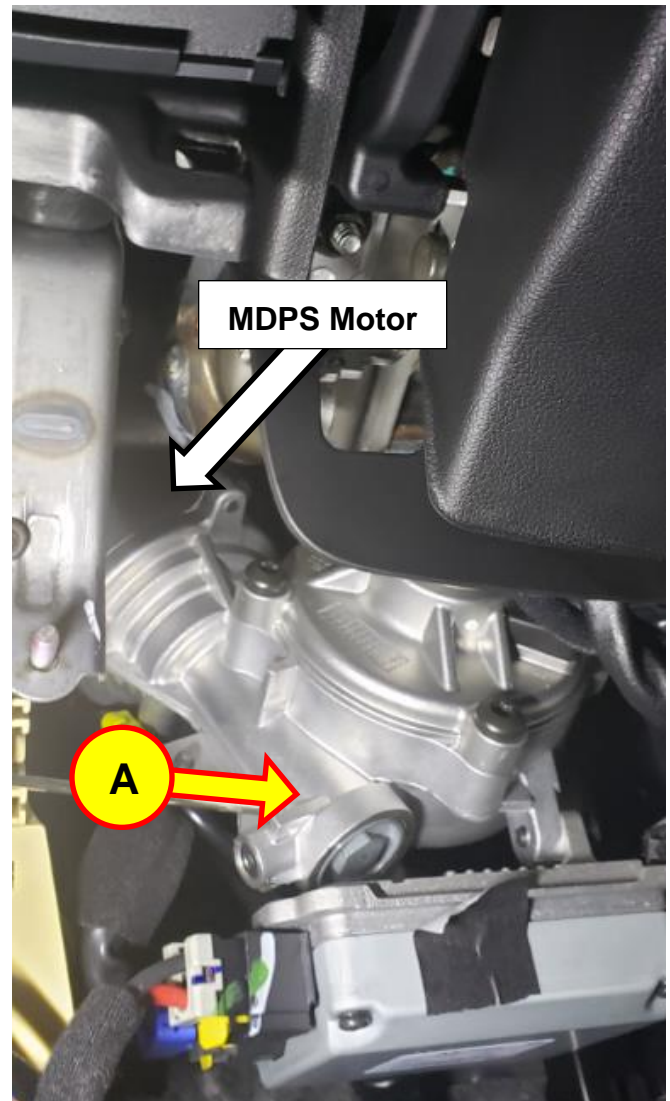
- Determine if bearing noise comes from the MDPS column and housing.
  - Start the engine and turn the steering wheel left and right.
  - Listen for the bearing noise occurring from the worm shaft housing (A). This noise will be located near the C-MDPS motor on the steering column.
  - To hear an example of the bearing noise, refer to the link below.  
<https://youtu.be/22PI3hAEfnk>
- Replace the worm shaft assembly if noise is heard.
