Technical Service Bulletin

GROUP STEERING	NUMBER 20-ST-003H-1
DATE SEPTEMBER, 2020	MODEL(S) Multiple

SUBJECT: C-MDPS WORM SHAFT BEARING NOISE

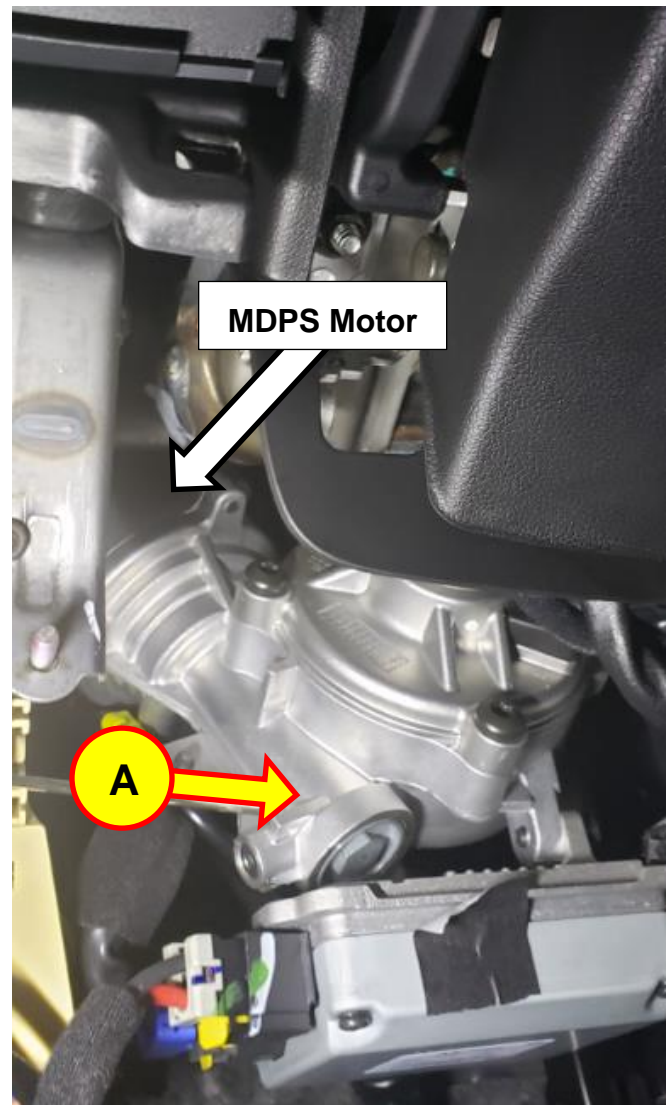
1. Determine if bearing noise comes from the MDPS column and housing.
 - Start the engine and turn the steering wheel left and right.
 - Listen for the bearing noise occurring from the worm shaft housing (A). This noise will be located near the C-MDPS motor on the steering column.
 - To hear an example of the bearing noise, refer to the link below.
<https://youtu.be/22PI3hAEfnk>
2. Replace the worm shaft assembly if noise is heard.

If noise is not heard in this location, refer to the shop manual for detailed diagnostic and repair service procedures or refer to TSB 20-ST-001H-2, Column-Mounted MDPS Repair Information (or current TSB related to partial C-MDPS Repairs) for additional information.
