SAFETY RECALL ACTION

Reference number:	RA-01-1418	Issued: 5th October, 2020
Subject:	Incorrect Installation of the Front Seat Airbags	
Model(s):	DB11, Vantage, DBS Superleggera	
VIN Range:	Refer to the separately published list of Vehicle Identification Numbers (VINs)	
Applicable to:	All Dealers	
Distribute to:	After Sales Manager Executive Manager Service Manager Sales Manager	Warranty Staff Technician(s) Parts Staff

Reason for this Safety Recall Action (NHTSA Reference 20V-604)

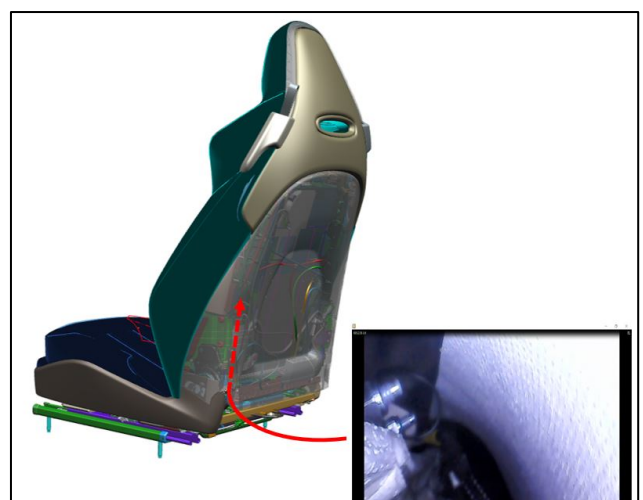
Figure 5

3. Use an endoscope on the underside of the seat to examine the two locking nuts for the seat airbag (refer to Figure 5).
