IMMEDIATE VEHICLE INSPECTION PRIOR TO SALE REQUIRED

To: All U.S. Volvo Retailers
Re: Delivery Action D10045: S60 Wheel Hub Bolts

**Delivery Action D10045: S60 Wheel Hub Bolts
Model Year 2021**

Deviation Description:

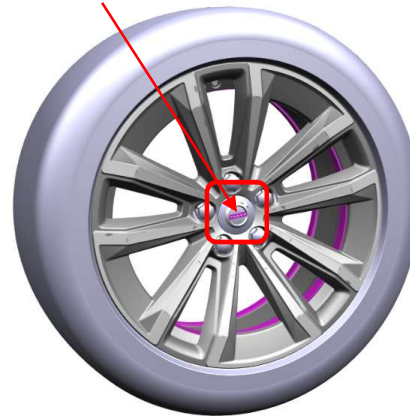
Pic 1: Remove wheel cap

Remove the wheel cap with the Volvo logo of both front wheels.

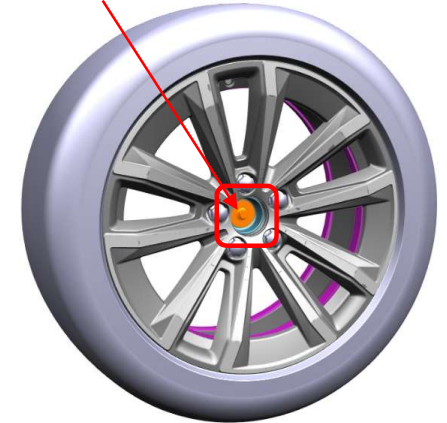
Pic 2: Visible wheel hub screw

- Inspect if bolt is torqued correctly using a torque wrench set on 50 Nm.
- If the bolt torque is less than 50 Nm, loosen the bolt and re torque the existing bolt to 45Nm+90deg.

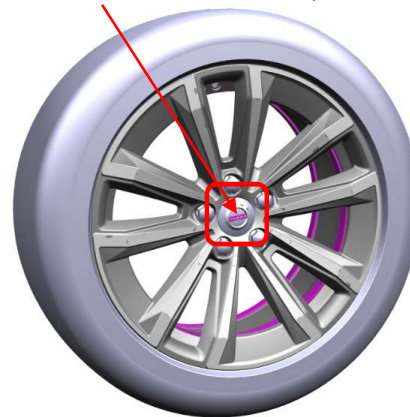
Pic 1: Remove wheel cap

Remove the wheel cap with the Volvo logo of both **front** wheels.

Remove the wheel cap with the Volvo logo of both **rear** wheels.

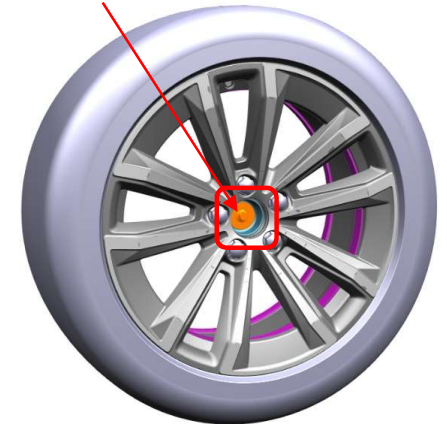
Pic 2: Visible wheel hub screw

- Inspect if a bolt is torqued using a torque wrench set on 50 Nm.
- If the bolt torque is less than 50 Nm, loosen the bolt and re torque the existing bolt to 45Nm+90deg.

- Inspect if a bolt is torqued using a torque wrench set on 50 Nm.
- If a bolt torque is less than 50 Nm, remove the existing bolt. Reassemble using a new bolt, part# 30670602, with a torque of 45Nm+90deg.
