**014\_BUGCS014\_Software\_Update\_VR17.2\_v1.4.docx**

Bugatti Chiron and derivatives

Vehicle Software update to latest homologated specification.

New Software package is available to fix minor bugs and add new workshop diagnostic functionalities. Details of impacted control units are listed below, may depend on vehicle level at delivery date.

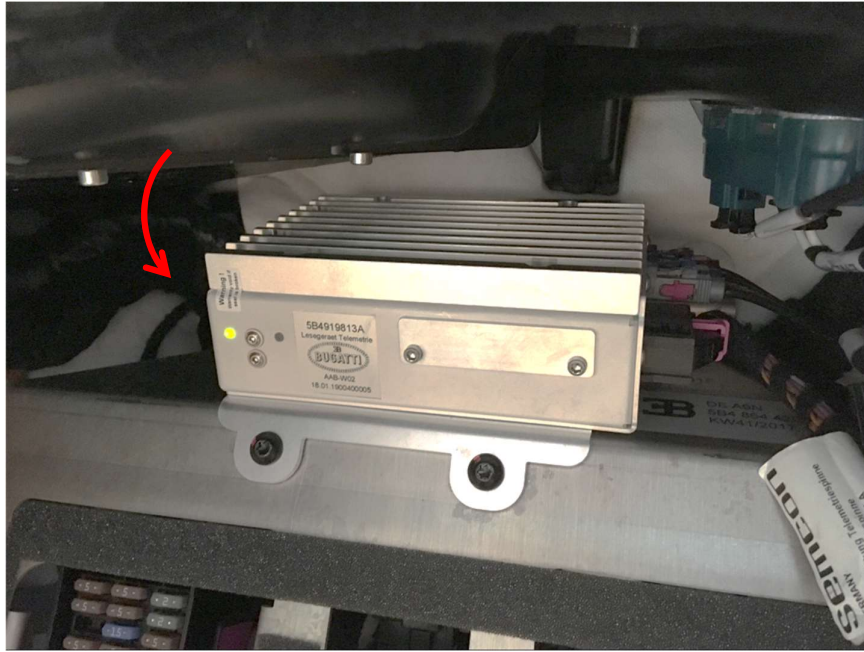
Figure 1 : General position of the TD Box in the car

A specific certification label, available at your Local ASM has to be brought on the TD Box as shown in the next picture (on the left side of the Box):

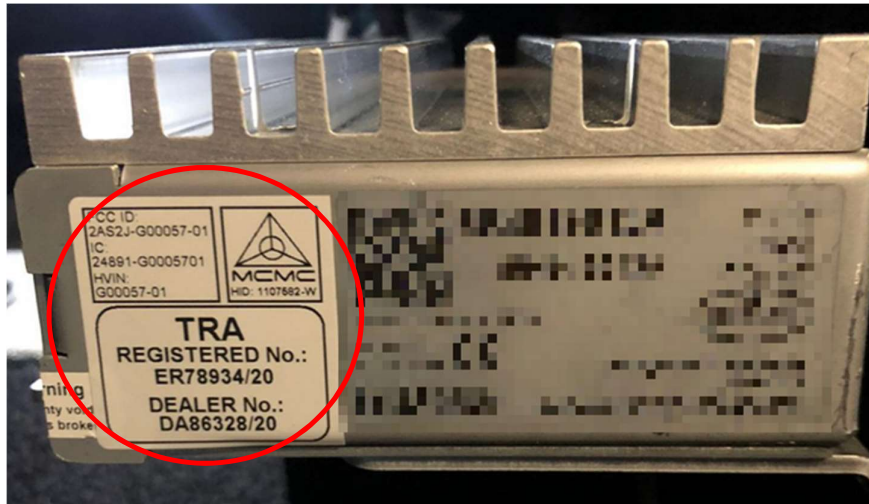
Figure 3 : Positioning of the certification label

A picture of the label on the TD box has to be sent to your Local ASM or attached to a Technical ticket.

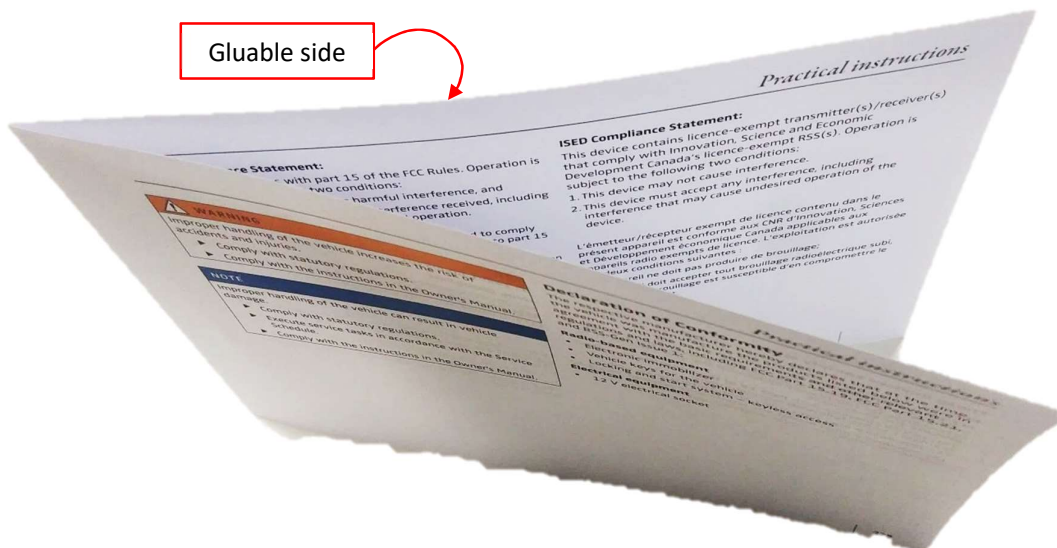
Figure 4 : New gluable double page n°275

A new “Double page n°275” has to be glued over the original page n°275; following these instructions:

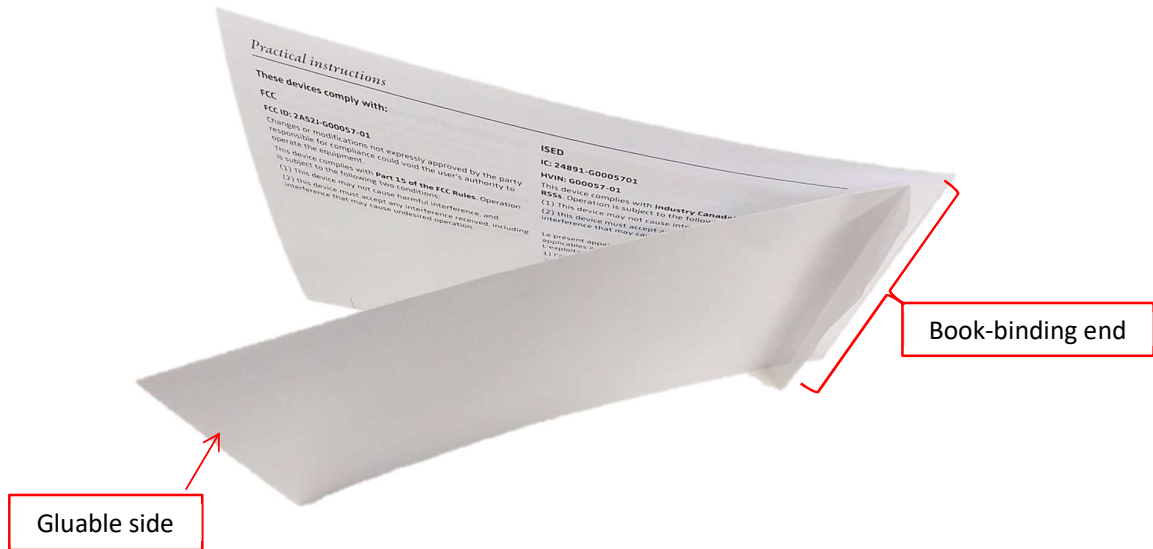
Figure 5 : Partial ungluing of the protective sheet

1. Lift up and fold back the first centimetre ( $\frac{1}{2}$  inch) of the protective sheet, on the book-binding end (see next picture).

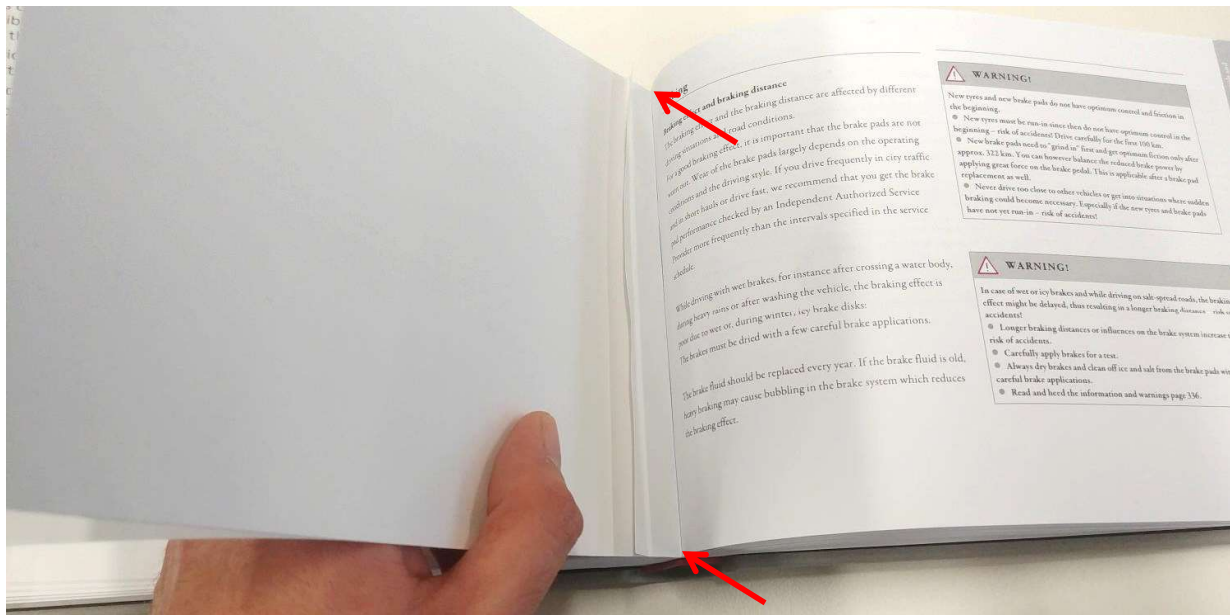
Figure 6 : Positioning of the new sheet in the book (Front view)

2. With the gluable side of the new sheet facing you, place it in a way to ensure it is fitted as far as possible in the book-binding, as shown in the following pictures

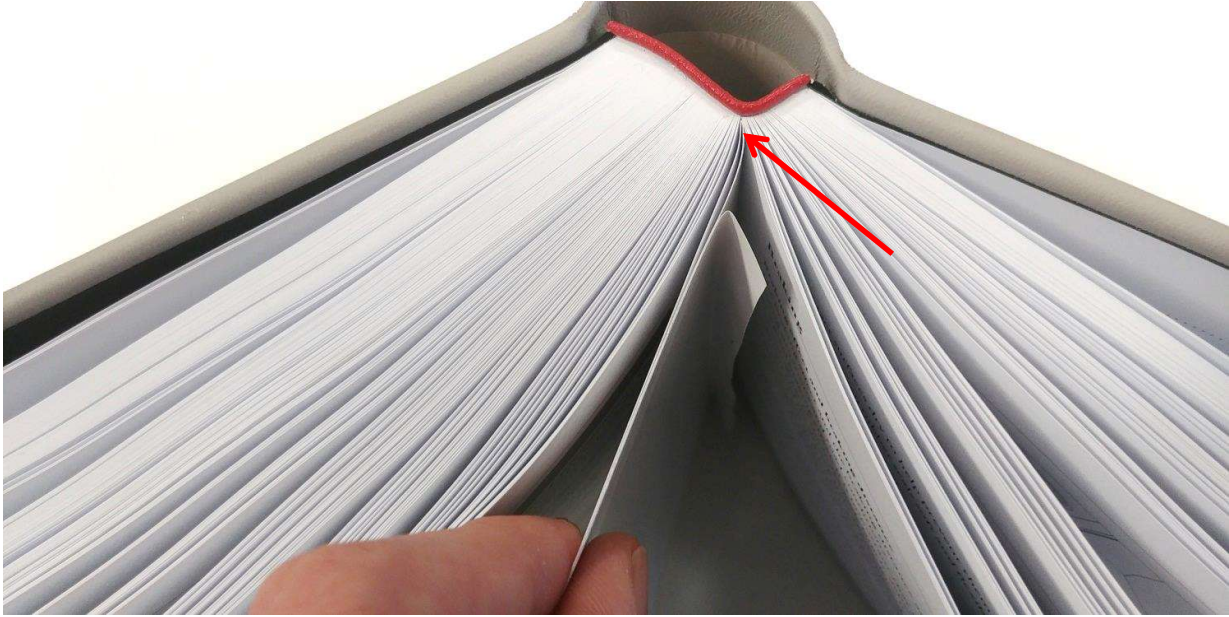
**Figure 7 : Positioning of the sheet in the book (Side view)**

Firmly maintain the page on the book, still ensuring it is as close as possible in the book-binding and fitting on the sheets under it.

The new Page 275 should be a few millimetres **shorter** than the original page.

A gap of about 2mm should exist on the outside of the page.

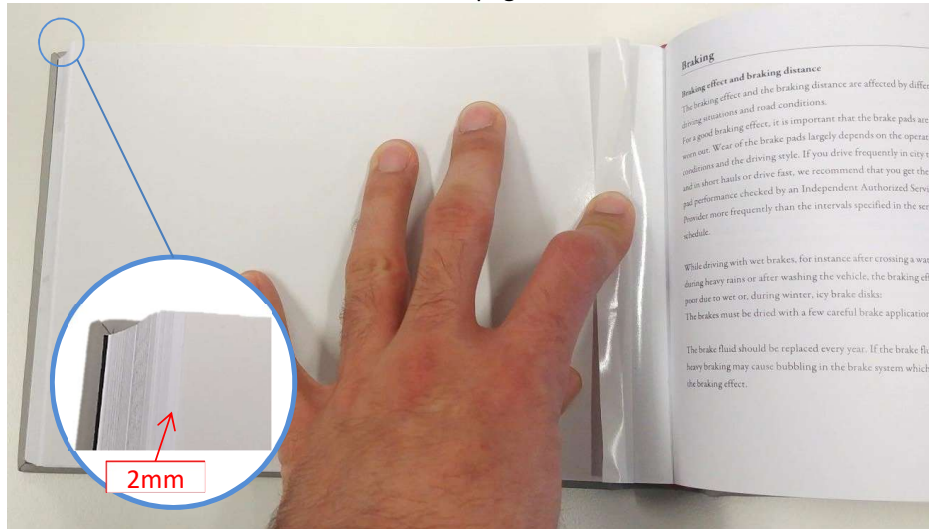
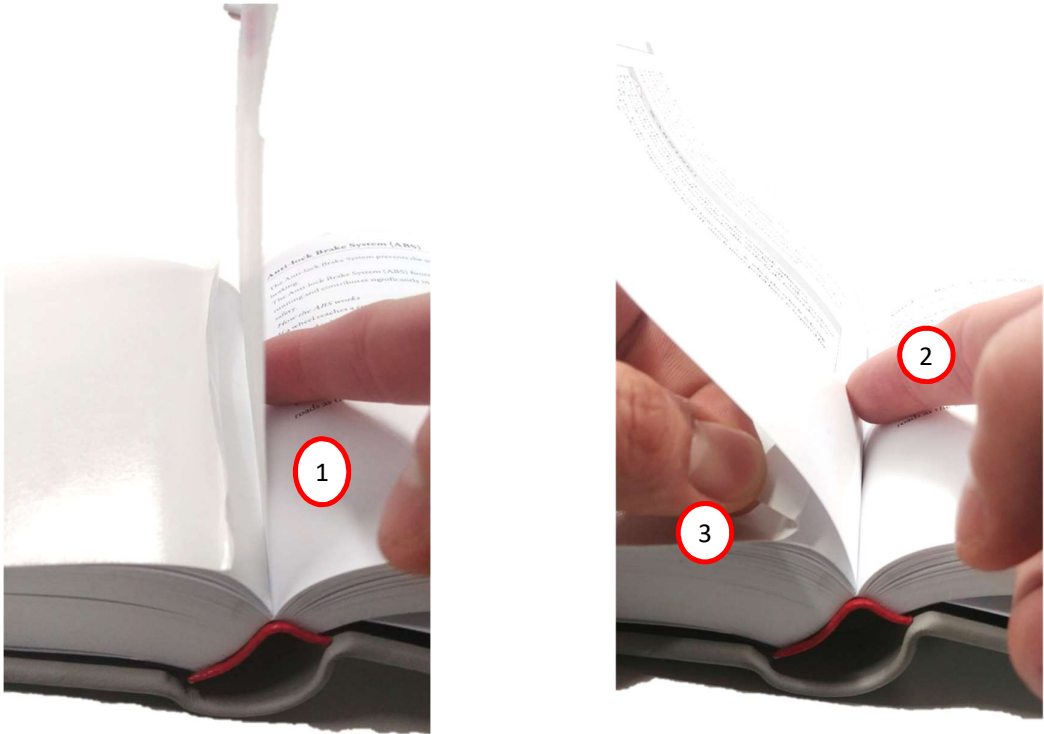
Figure 8 : Gluing procedure

Still ensuring the sheet is fitting in the book-binding (1), fold down the page over the gluing side of the new sheet (2) while taking out the protective sheet of the gluing side (3).
