2019FA07, Rev. E  
September 16, 2020  
Product Code(s): 65, 66  
Page 1 of 15

**SUBJECT:** Special Coverage for TIDB Aluminum Main Valve Body – Reactive

**MODELS AFFECTED:** 3000 Series™, 4000 Series™, B200™, B300™, B3400 xFE™, B400™, B500™, T200™, T300™, T400™, T500™ Models

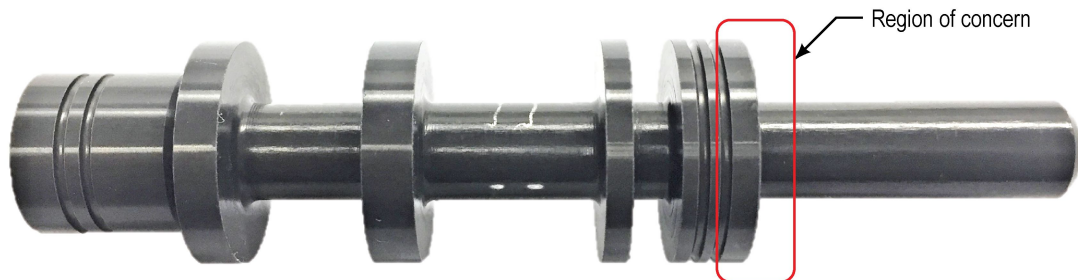
**Figure 1.**

**NOTE:** Closely inspect the Main Regulator Valve P/N 29563501 for the presence of a manufacturing burr shown in [Figure 1](#) and [Figure 2](#) below. See [SIL 01-WT-20](#) for additional clarification.

**NOTE:** Prior to re-using the PS1 Switch Assembly or PS2 Switch Assembly, closely inspect the O-ring of each switch for damage. If either O-ring is questionable, replace the part.
