2020FA01, Rev. B  
September 16, 2020  
Product Code(s): 65, 66  
Page 1 of 12

SUBJECT: Special Coverage for TIDB Main Regulator Valve P/N 29563501 – Reactive

MODELS AFFECTED: 3000, 4000 Series, B200™, B300™, B3400 xFE™, B400™, B500™, T200™, T300™, T400™, T500™ Models

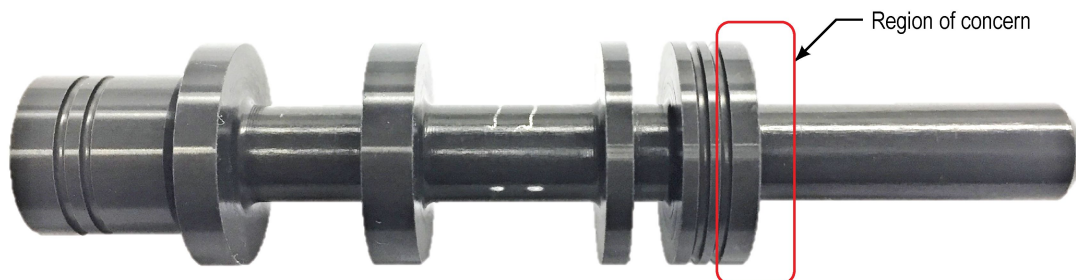
**Figure 1.**

Allison Transmission, Inc. has identified a potential concern with the TIDB Main Regulator Valve P/N 29563501. The concern is related to a manufacturing burr on the valve OD (refer to [Figure 1](#) and [Figure 2](#) in this document or SIL 01-WT-20 for additional detail). As a Global Customer Satisfaction initiative, Allison Transmission, Inc. will support the reactive repair of units with symptoms attributable to the subject part in the serial number ranges identified in [Table 1](#) for five years from the in-service date of the vehicle. This Field Action does not cover transmission service work unrelated to the symptoms described within.

**NOTE:** Closely inspect the Main Regulator Valve P/N 29563501 for the presence of a manufacturing burr shown in [Figure 1](#) and [Figure 2](#) below. See SIL 01-WT-20 for additional clarification.

- Use [Table 6](#) to support a Product Code 66 4000 Series™ 7-speed unit
5. Replace parts listed in [Table 3](#), [Table 4](#), [Table 5](#), or [Table 6](#) per the Service Manual SM4013 or SM4014 Control Module Overhaul procedures.

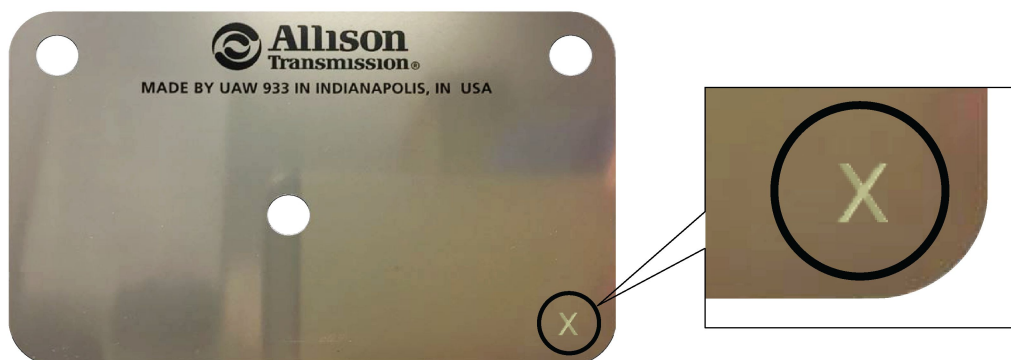
**Figure 3. Identification Mark**

1. Confirm the transmission is within the affected S/N range per [Table 1](#).
2. Verify the transmission nameplate does not have the "X" Identification Mark indicating Field Action service work has already been performed (refer to [Figure 3](#)).

7. Fill transmission with the same type of fluid that was drained. Reset Fluid Life Monitor as-required.
8. Stamp or etch an "X" identification mark into the transmission nameplate in the location shown in [Figure 3](#).
