Popping/Crackling from the Speakers; Display Blank

Supersedes 20-031, dated September 25, 2020, to revise the information highlighted in **yellow**.

AFFECTED VEHICLES

Year	Model	Trim Level	VIN Range
2019-20	RDX	ALL	ALL

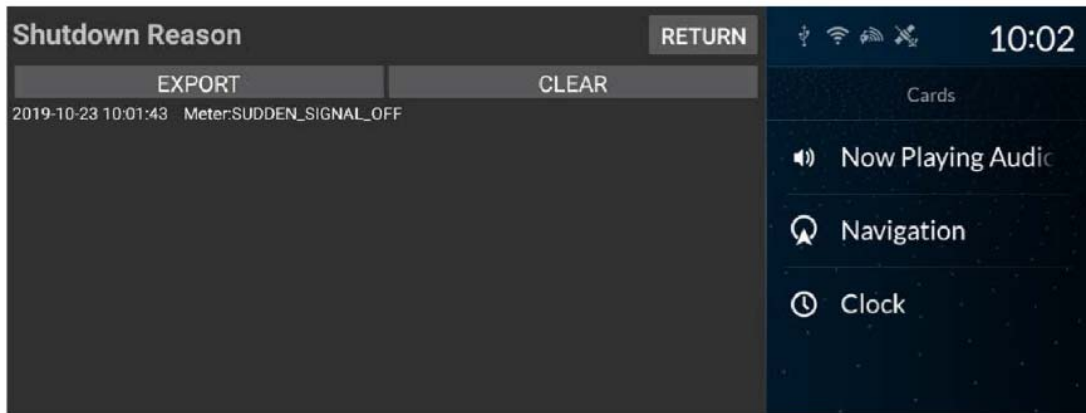
In this example, the cause of the failure can be identified as **Meter:SUDDEN_SIGNAL_OFF**.

4. Write down any failures as they will be collected on the warranty claim. Then, clear the data.

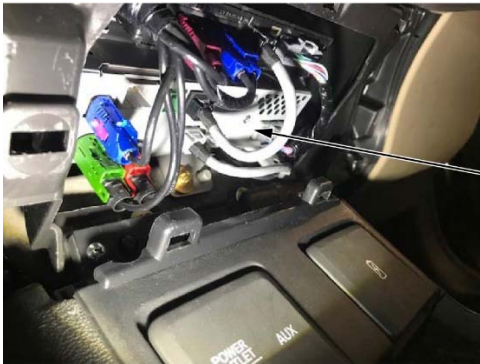
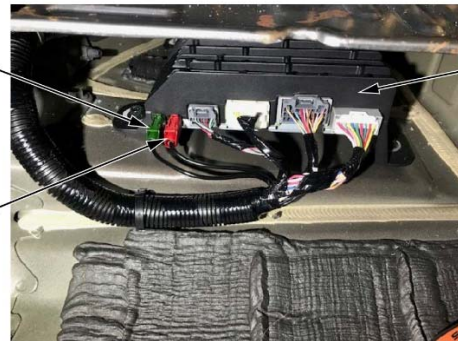
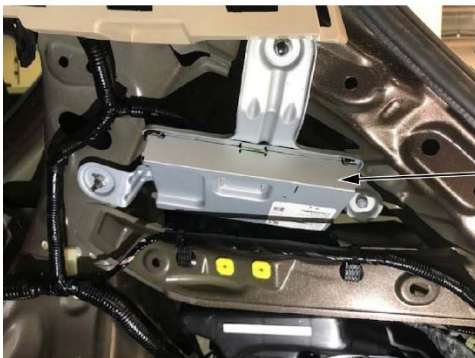
19. Disconnect the red and green MOST connectors at the infotainment, stereo amplifier, and tuner units using the straight FAKRA puller.

20. Using a small flat-tip screwdriver, remove the secondary lock, then break off the tab as shown.

21. Pull and twist counterclockwise to remove the housing from the wire. Then, discard the housing and lock.

22. Select the correct color FAKRA housing, then slide the new terminal onto the wire until it clicks into place.

23. Line up the locking tabs of the FAKRA housing to the new terminal, then slide the new terminal into the housing until it clicks.
