# McLaren Senna – Left Engine High Temperature Radiator (HTR) Fan Wiring Harness Rework

| <b>Bulletin type:</b> | Service Campaign |
| <b>Reference number:</b> | SCB 15 M 002 |

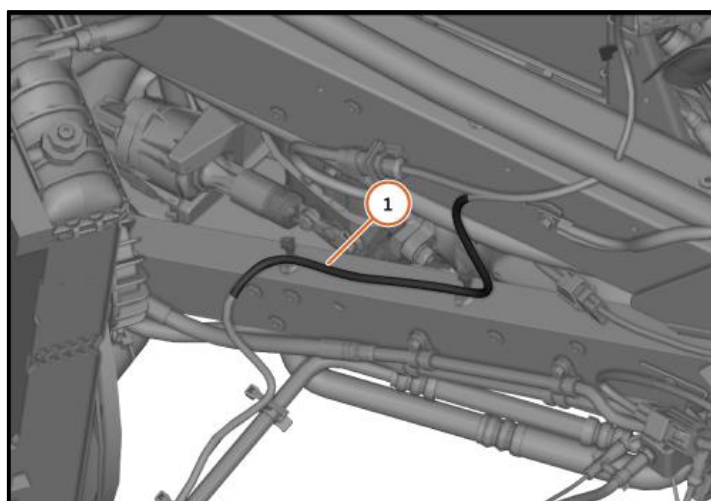
Through continuous product quality monitoring, it has been identified that a number of McLaren Senna vehicles may experience a concern where the Left Engine High Temperature Radiator (HTR) fan wiring harness becomes loose from its fixing points. This could cause damage to the components; therefore, a preventive rework solution has been released.

Layout overview - Left HTR wiring location for required rework (1)  
(extract from SCB 15 M 002 WI)

Document SCB 15 M 002 WI (attached with this Bulletin) contains the relevant work instructions and care points to ensure the repair is carried out correctly, bringing the vehicle up to the current manufacturing standard.
