McLaren Senna GTR – Brake Wear Sensor Cable Routing

Bulletin type:	Service Campaign
Reference number:	SCB15 M 003
Attention:	Retailer Service Managers and Retailer Technicians
Affected vehicles:	McLaren Senna GTR
Situation:	Routing of the brake wear sensor cable in the wheel arch area may be incorrect
Procedure:	Action affected vehicles during next Retailer visit. Please refer to the information outlined in this document to re-route the concerned cable on the front and rear of the vehicle
Date:	12 th March 2020

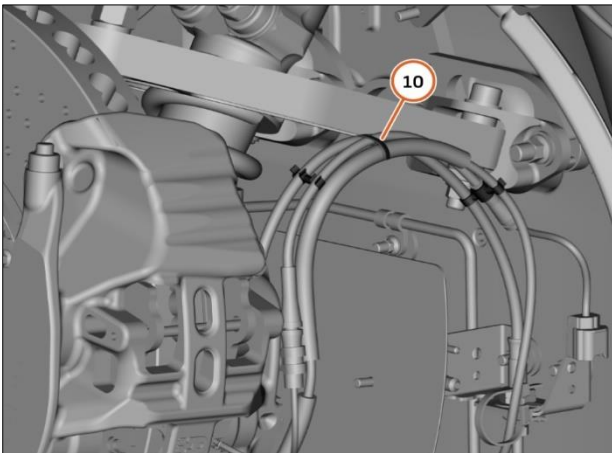
Extract from SCB15 M003 WI - Overview of correct front wiring routing

To carry out the required work, check the installation condition and carry out re-routing as required.

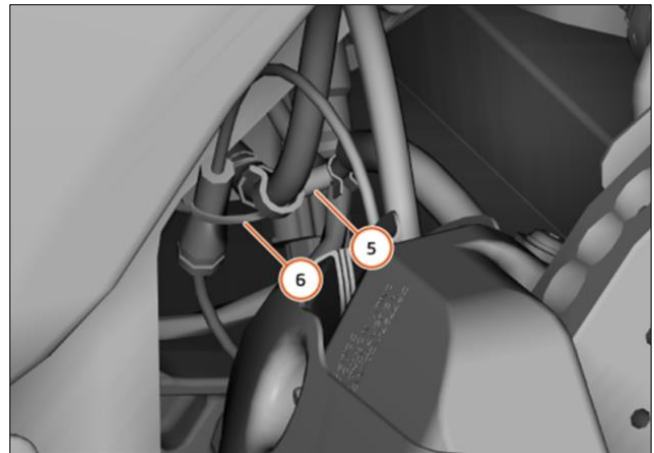
Extract from SCB 15 M 003 WI - Overview of correct rear wiring routing
