# Technical Service Bulletin

<b>Technical Service Bulletin:</b> TSB190165	<b>Released Date:</b> 28-Sep-2020
<b>Soot or Ice Deposits in the Intake Air Connection:</b> FC1866, FC3361, FC3382, FC3383, FC3389, FC7233 and/or FC4729

## Soot or Ice Deposits in the Intake Air Connection: FC1866, FC3361, FC3382, FC3383, FC3389, FC7233 and/or FC4729

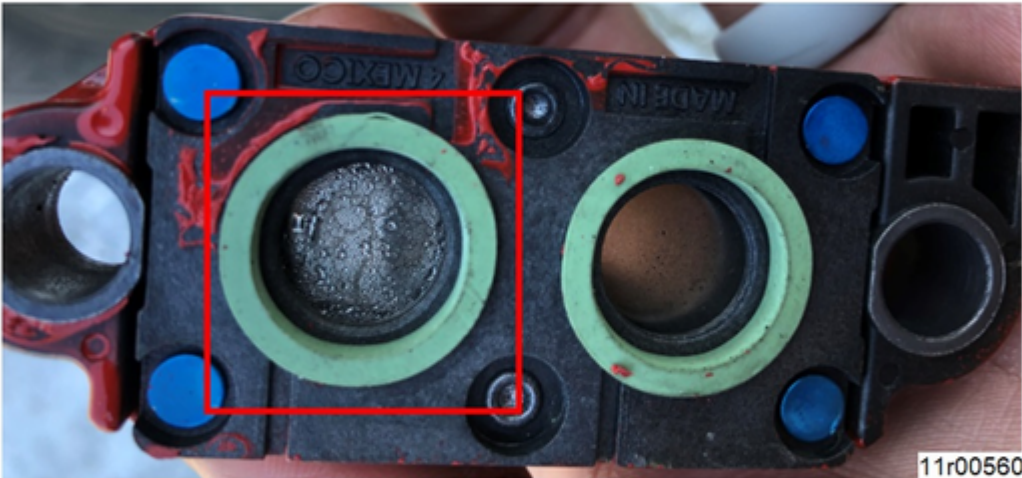
- Icing/condensation in the intake air connection exhaust gas recirculation (EGR) differential pressure sensor or horizontal and vertical ports are present and have affected EGR flow measurements.
  - Icing may **not** be present at the time of the repair, but presence of condensation/water droplets in the EGR Differential Pressure sensor indicates that icing of the sensor is the root cause of this issue.

Figure 1, Condensation on the EGR Differential Pressure Sensor.

- If soot is found, gently wipe away with a clean towel. Be sure not to apply too much pressure on the sensor elements, as they can become damaged.
  - If ice or condensation is found (See Figure 1 below), gently wipe away with a clean towel. Be sure **not** to apply too much pressure on the sensor elements, as they can become damaged.
