## Preliminary Information

### PIT5737B Loss of Sirius XM Audio Until XM Channel Change

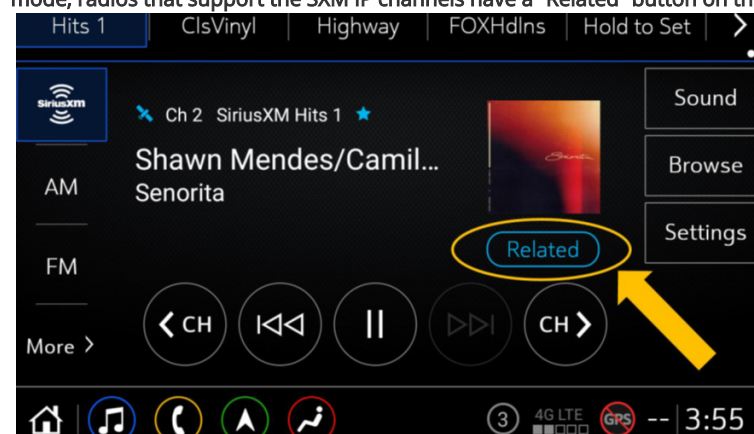
To visually identify if the radio may be involved, switch to the Audio page and select SXM as the Source and look for the "Related" button. When in SXM mode, radios that support the SXM IP channels have a "Related" button on the screen.
