Preliminary Information

PIP5748A Particulate Matter Sensor Protection Tube Performance Diagnostic May Set A False DTC P1488

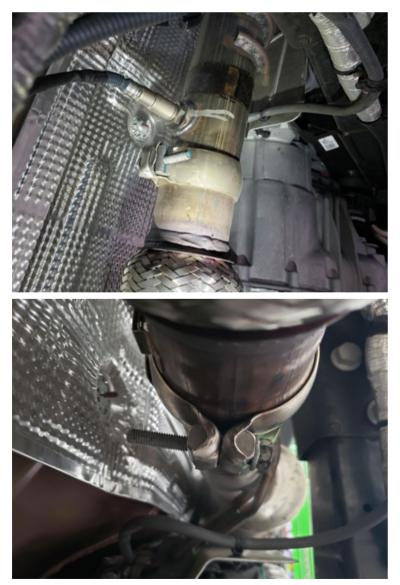
If the sensor is properly torqued and the P1488 has requested the MIL, test the exhaust for leaks using the power smoke diagnostic leak detector (GE-52250 - refer to the latest version of PIP5684). Repair any leaks as necessary but pay particular attention to the joint illustrated in the pictures below. If the joint is leaking the clamp may have bottomed out before applying sufficient clamp load to the joint. If this condition exists, replace the clamp.

Also replace the particulate matter sensor.
