Preliminary Information

PIP5755 Diagnostic Tip: Potential Oil Leak From Cam Carrier Gasket T- Joint Area

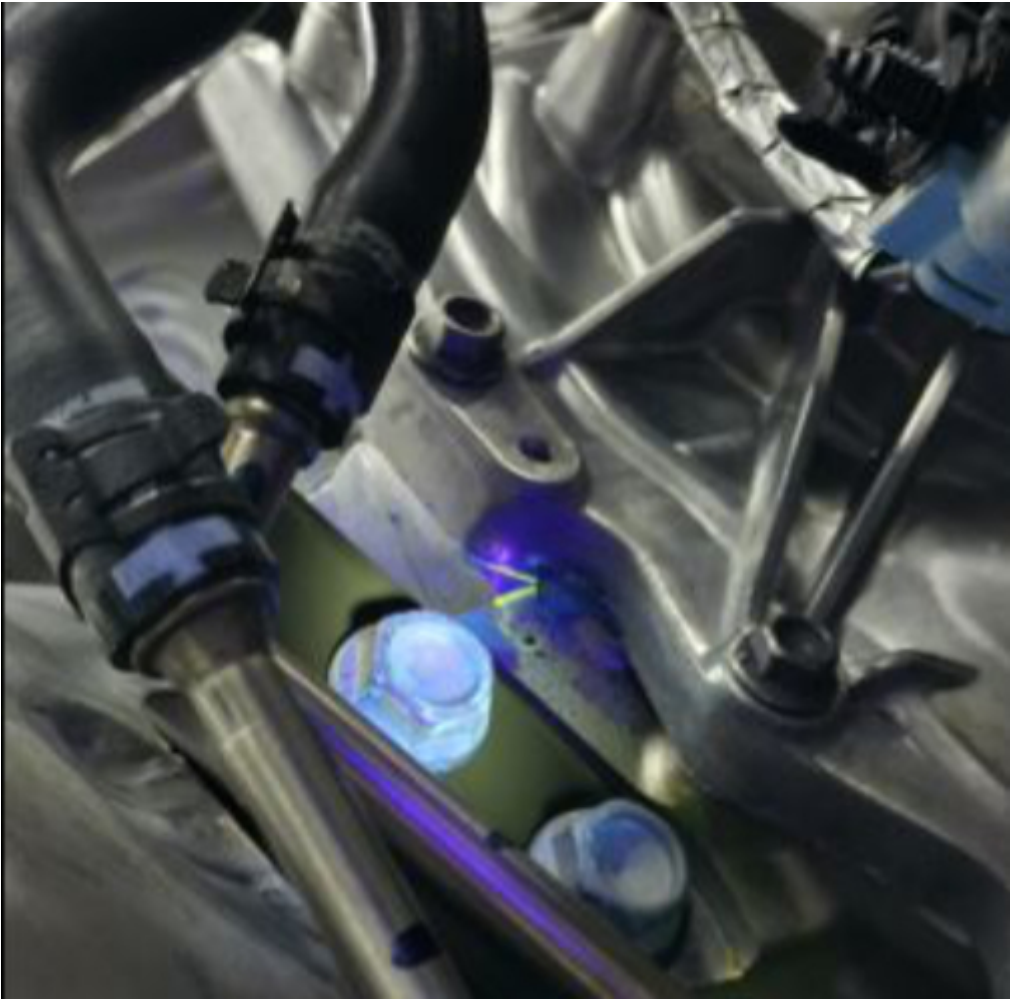
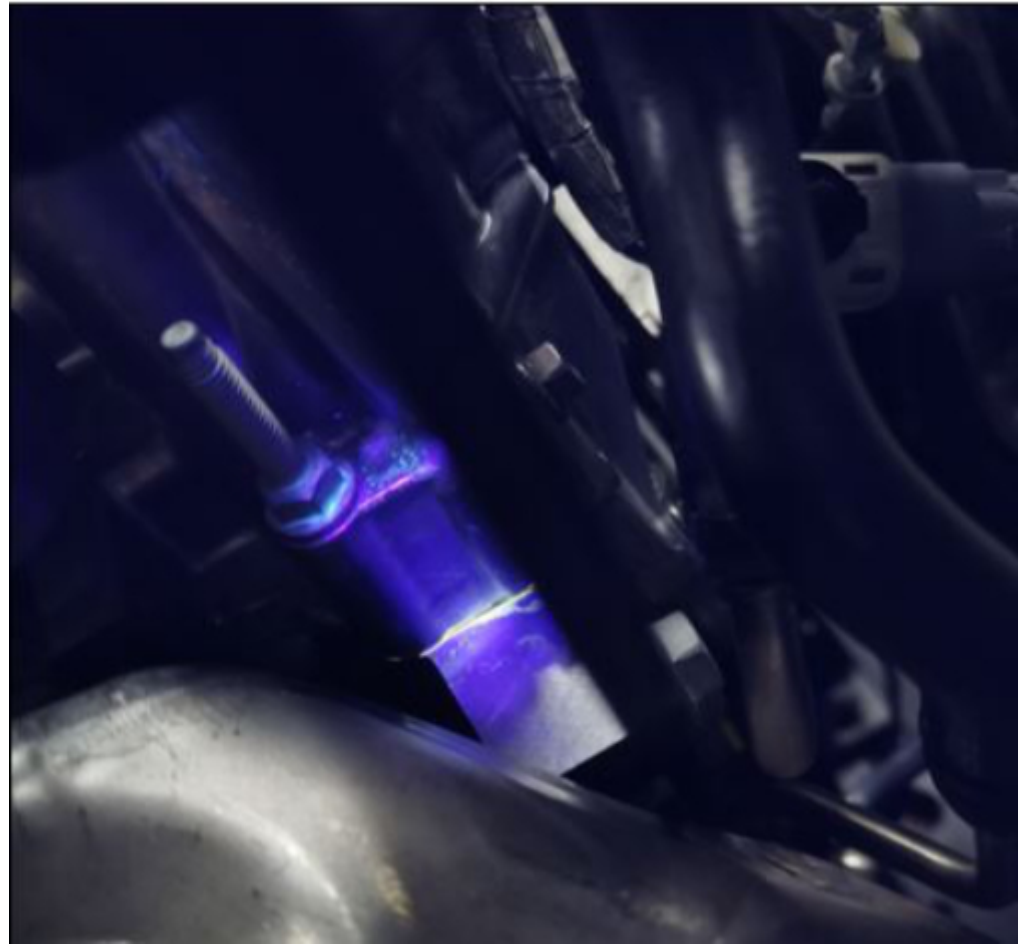
Involved Region or Country:	North America
Condition:	Potential oil leak from cam carrier gasket.
Cause:	Improper amount of sealer applied to recommended areas of cam carrier gasket T- joint area.

Pictures below show the Cam Carrier T joint area using a black light to highlight the oil dye.

If the oil leak has been isolated to the Cam Carrier T joint area refer to the latest Service Information for resealing the Cam Carrier Assembly.
