Bulletin No.: PIP5753
Published date: 09/30/2020

PIP5753 Lack Of Engine Performance and/or DTCs P003A, P0046, P0299 and/or P0234 May Set

Models

Brand:	Model:	Model Years:	VIN:		Engine:	Transmissions:
			from	to		
Chevrolet	Silverado	2020 - 2021	All	All	LM2	All
GMC	Sierra	2020 - 2021	All	All	LM2	All

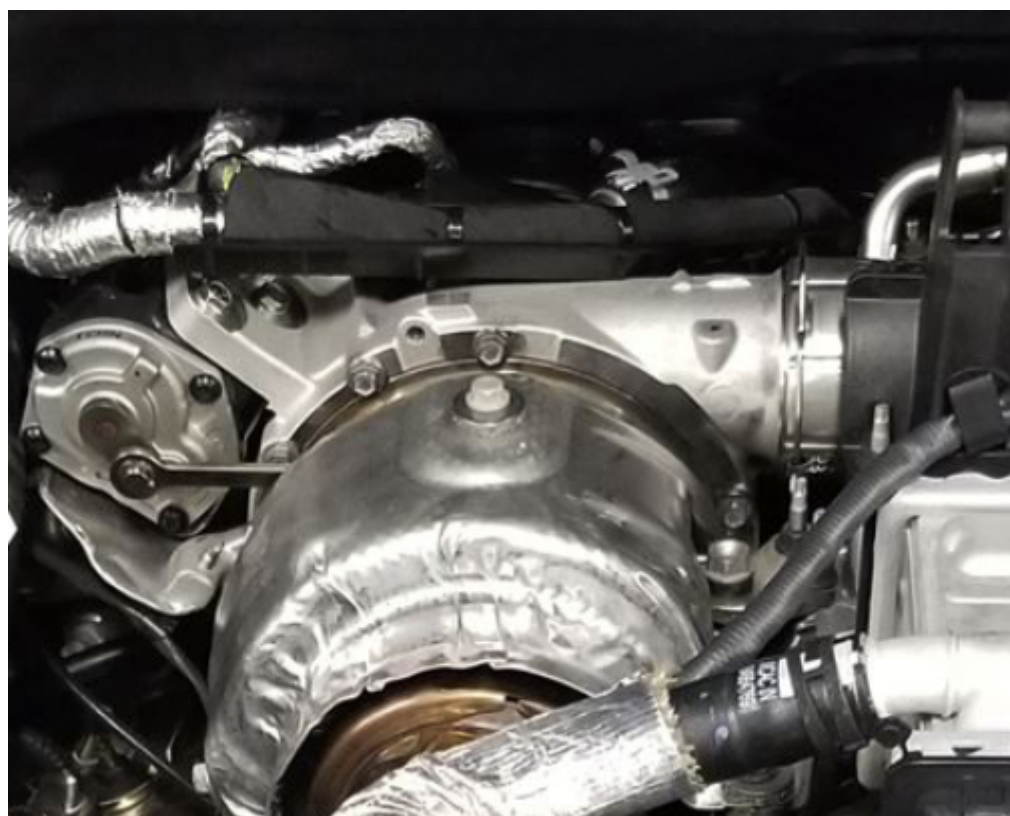
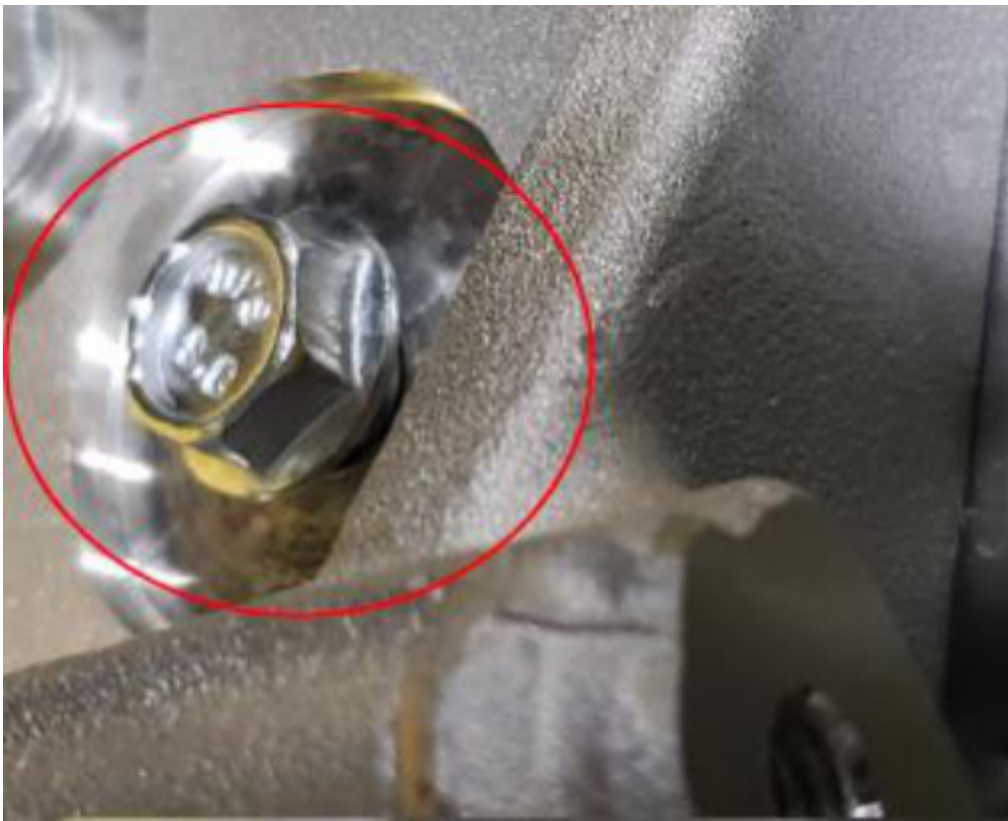
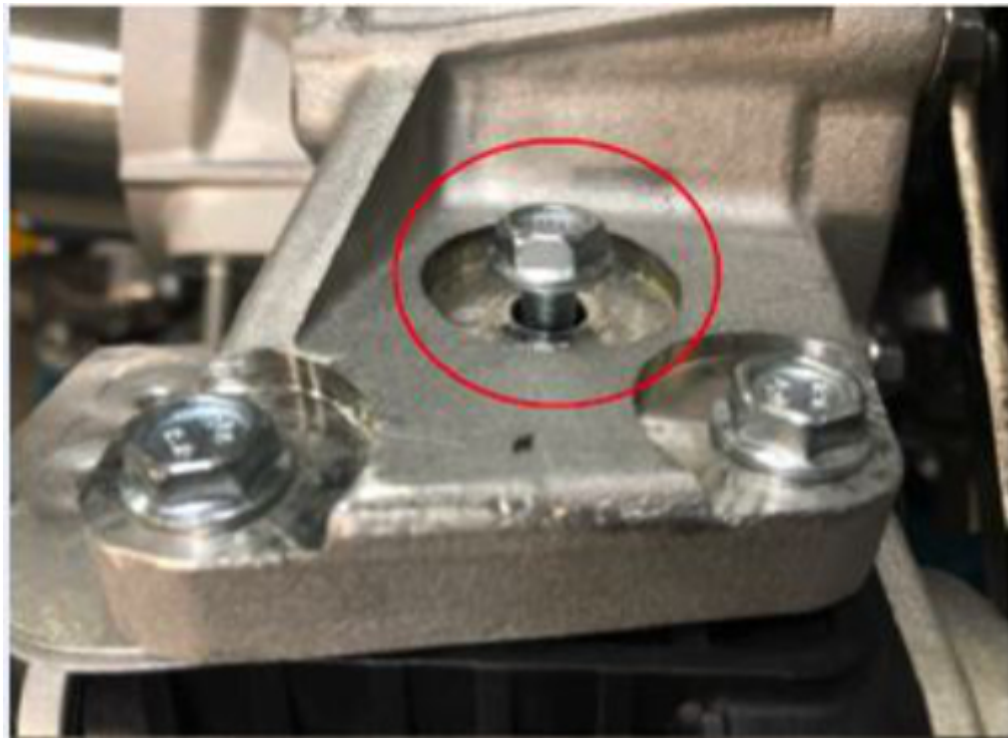
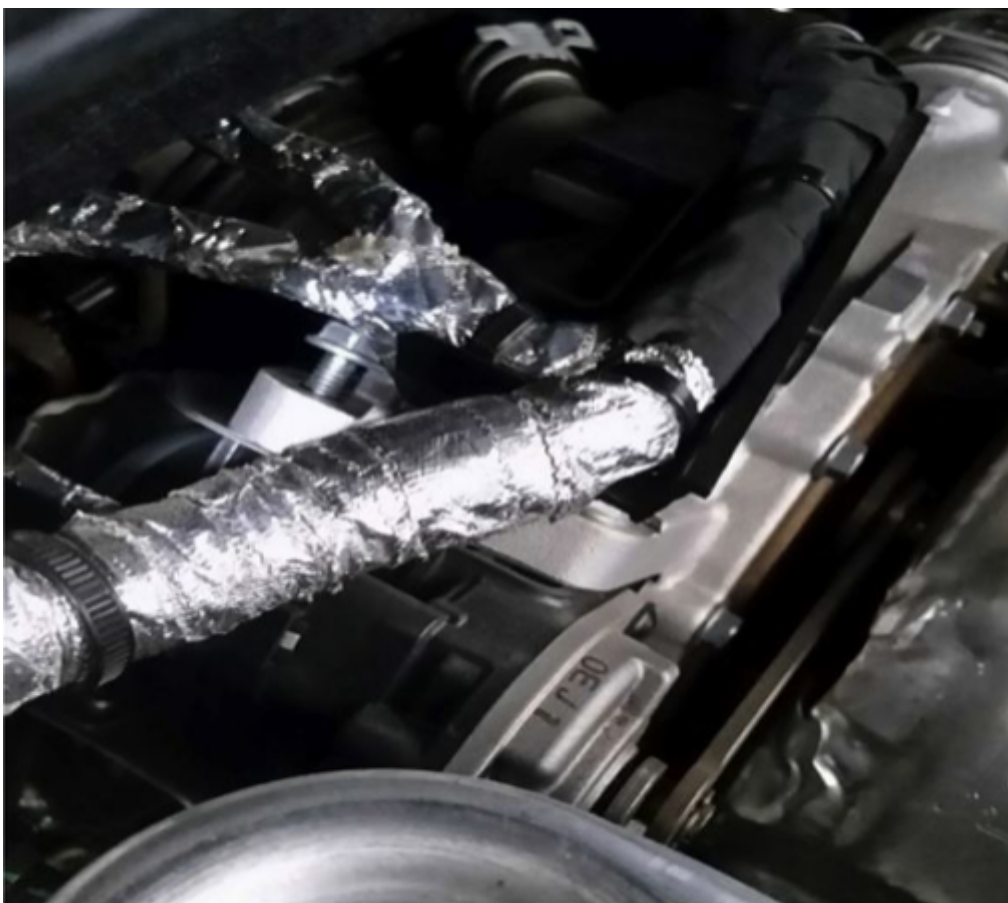
Involved Region or Country	North America
Condition	A customer may have a concern with lack of engine performance and/or DTCs P003A, P0046, P0299 and/or P0234 may set.
Cause	These conditions may be caused by loose bolts on the turbocharger actuator, as indicated in the pictures below.

If any of the three actuators bolt are not fully seated, replace the turbocharger. If all the bolts are fully seated, this PI does not apply. Continue with normal Service Information diagnostics.
