Technical Service Bulletin

90 Audi pre sense - restricted function icon is displayed after engine starts

90 20 73 2059891/3 October 7, 2020. Supersedes Technical Service Bulletin Group 90 number 20-68 dated September 15, 2020 for reasons listed below.

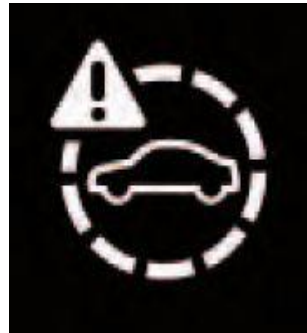
- One of the symbols for “Audi pre sense not available at the moment” is shown for about 20 seconds after engine starts and then it disappears (Figures 1 - 2).
- In some models, the vehicle must be moved before the initialization indicator goes out.

Figure 1. Symbol for “Audi pre sense not available at the moment”.

This icon is shown for about 20 seconds after switching on the ignition, because Audi pre sense is not available at the time. The front camera for driver assist systems R242 needs about 20 seconds, or, in some models, a velocity signal, to start up.

1. Do not perform any repairs. Any repairs for this concern may be denied.
2. Inform the customer that it takes the front camera for driver assist system (R242) about 20 seconds to start up and the icon informs the driver of this fact. This is normal behavior.
