## BR167 / MFA2 Cracks In Artico Seat Cushion Cover On Front Seat

Topic number	LI91.18-P-071629
Version	1
Function group	91.18 Seat covers
Date	08-31-2020
Validity	BR 167 with imitation leather seat covers (Artico) BR 177, 118, 247 with imitation leather seat covers (Artico) and seat climate control (SA 401)
Reason for change	
Reason for block

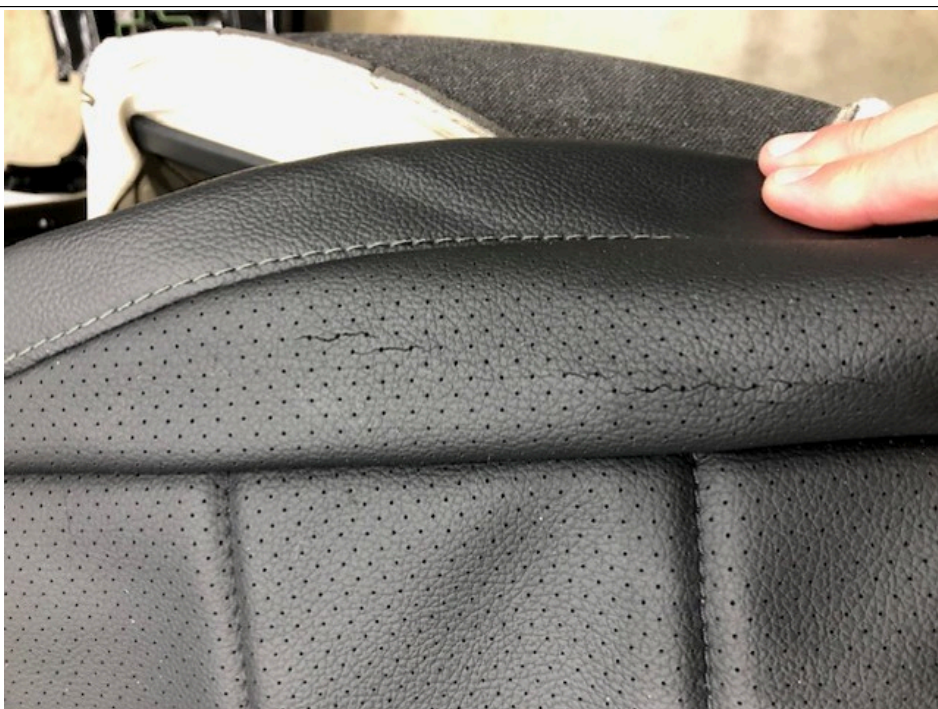
example1.jpg:

There may be cracks in the seat cushion cover (Artico imitation leather) on the front seat.
