SIB 32 04 20

GROANING NOISE DURING HEIGHT ADJUSTMENT OF THE ELECTRIC STEERING COLUMN

F90 (M5 Sedan)	F91 (M8 Convertible)	F92 (M8 Coupe)	F93 (M8 Gran Coupe)
F95 (X5 M Sports Activity Vehicle)	F96 (X6 M Sports Activity Coupe)	G05 (X5 Sports Activity Vehicle)	G06 (X6 Sports Activity Coupe)
G07 (X7 Sports Activity Vehicle)	G12 (7 Series Sedan)	G14 (8 Series Convertible)	G15 (8 Series Coupe)
G16 (8 Series Gran Coupe)	G30 (5 Series Sedan)	G32 (640i xDrive Gran Turismo)

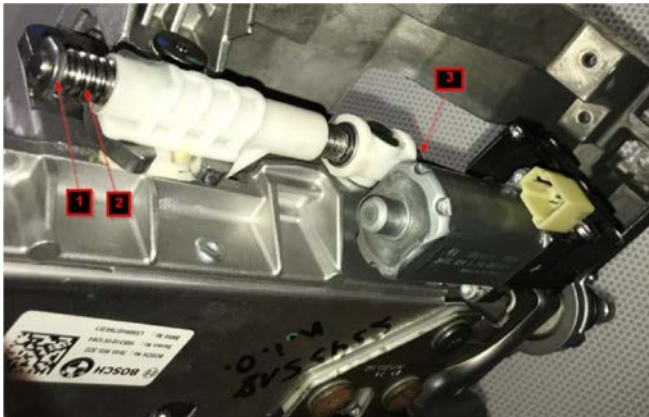
The spindle drive (2) is located on the right side of the steering column as viewed from the driver's seat

The stop panel (1) of the spindle drive will need to be turned 90 degrees clockwise.

Before adjusting the stop spindle, the lock nut in the rear of the drive (3) must be secured in place
