SIB 61 18 20

2020-09-17

## BMW TURBOCORD PORTABLE EV 120 V/240 V CHARGER

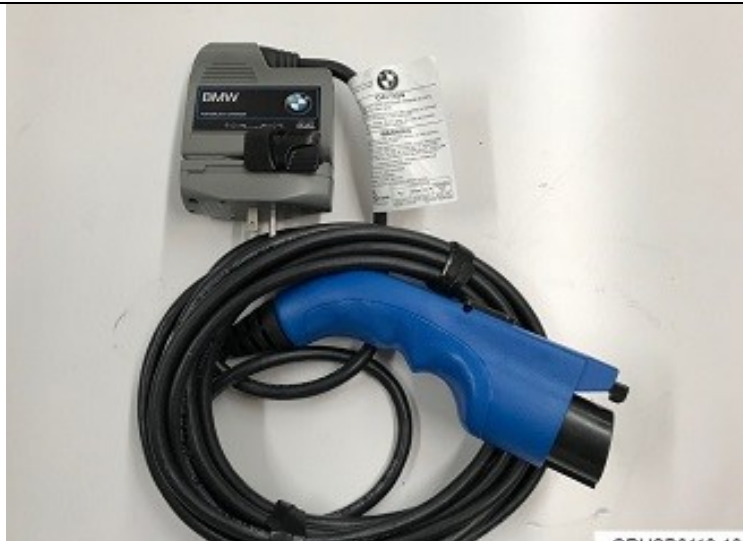
<p><b>Accessory offering (shown):</b></p> <p>TurboCord Charger (complete)</p> <ul style="list-style-type: none"> <li>• P/N 61 44 2 448 670</li> </ul> <p><b>Specifications:</b></p> <p>Dual voltage mode electric vehicle charging device</p> <ul style="list-style-type: none"> <li>• 12 A @ 120 Volts</li> <li>• 16 A @ 240 Volts</li> </ul>
--	--

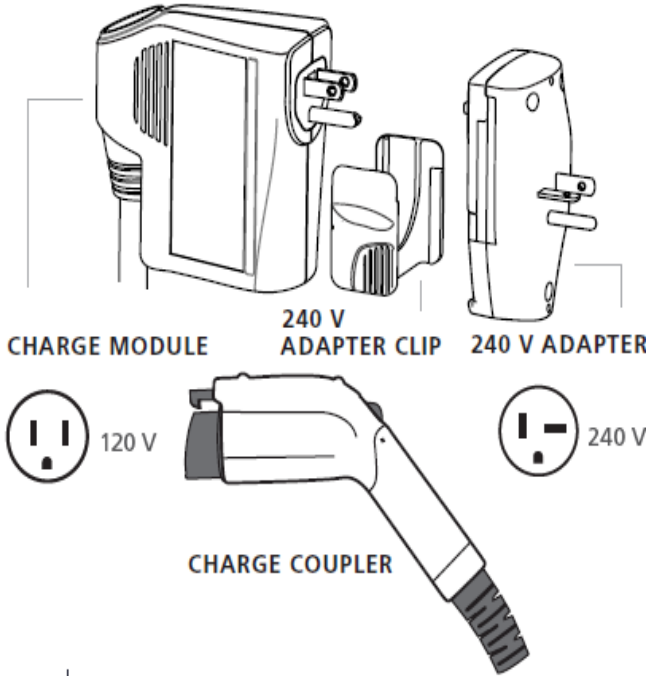
<p>CHARGE MODULE      240 V ADAPTER CLIP      240 V ADAPTER</p> <p>120 V      240 V</p> <p>CHARGE COUPLER</p>	<p>D. Test the TurboCord on <b>120 V (level 1) charge mode</b> by plugging it into a (known good) 120 V supply outlet and to the vehicle's charge socket.</p> <p>E. If the TurboCord charger does <b>NOT</b> operate/charge the vehicle on <b>120 V charge mode</b>, replace the complete <b>TurboCord Charger PN 61 44 2 448 670</b>.</p> <p>F. If the TurboCord operates/charges the vehicle on <b>120 V charge mode</b>, proceed to step G.</p>

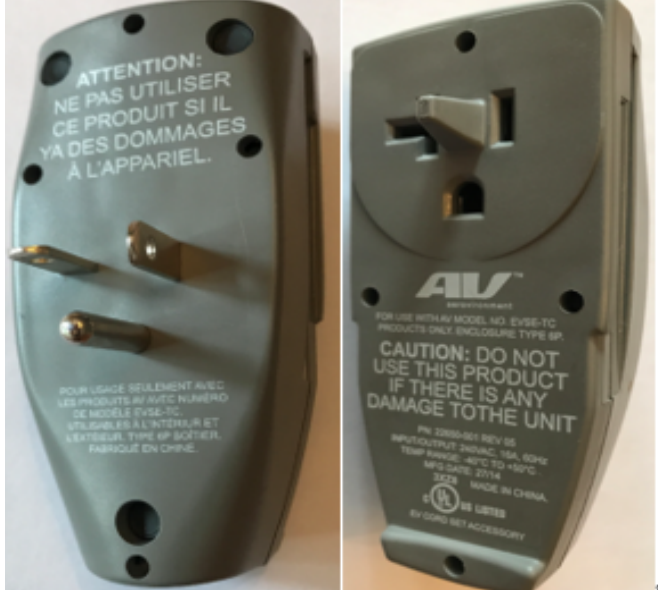
<p>G. Test the TurboCord on <b>240 V (Fast charge mode)</b> by plugging into a (known good) 240 V supply outlet and to the vehicle's charge socket.</p> <p>H. If the TurboCord charges properly on <b>120 V (level 1) charge mode</b> but it does <b>NOT</b> operate/charge on <b>240 V (Fast charge) mode</b>, replace the 240 V Plug Adapter shown with <b>PN 61 44 5 A2A D29</b>.</p>
