SIB 64 03 20

2020-09-28

CENTER CONSOLE / CUP HOLDER GETS HOT WHEN THE HEAT IS ON

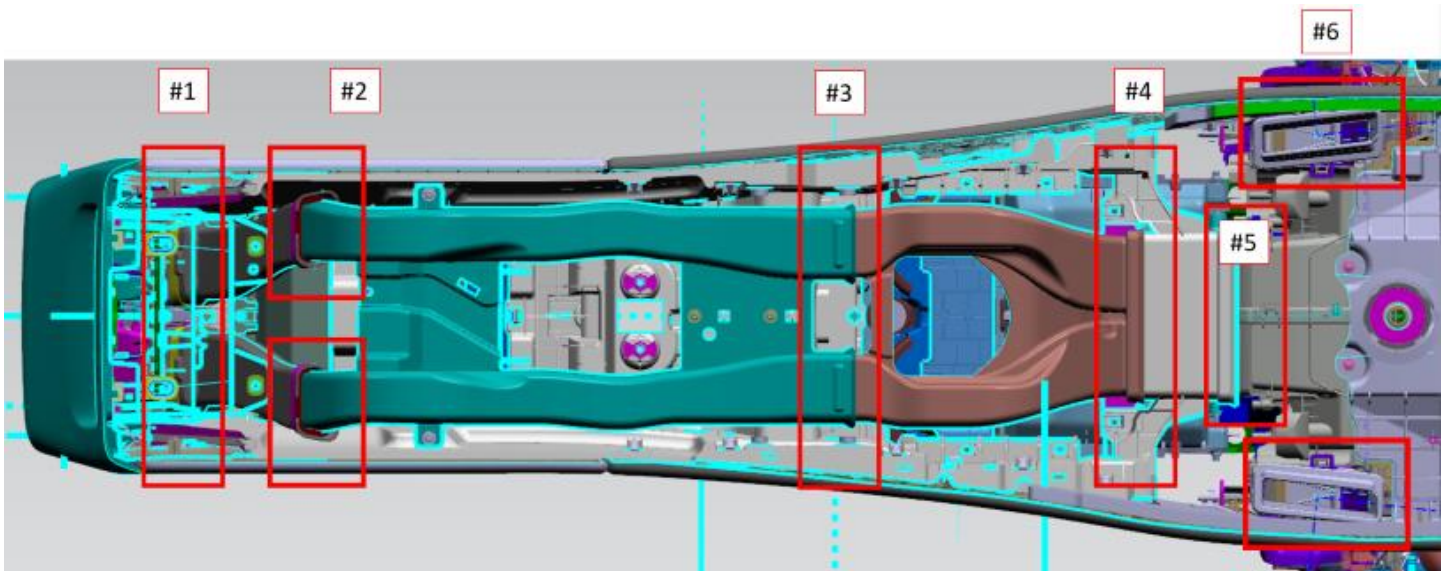
The air ducts may not be properly connected, this allows heated air to leak out in this area.

The foam material that seals between the ducts may be out of position, not held by the mounting adhesive and squashed allowing for an air leak. This leak can occur at any of these 6 junction locations:

1-Check foam seal material at duct connections and replace foam as needed. Ensure ducts are properly overlapped on installation.

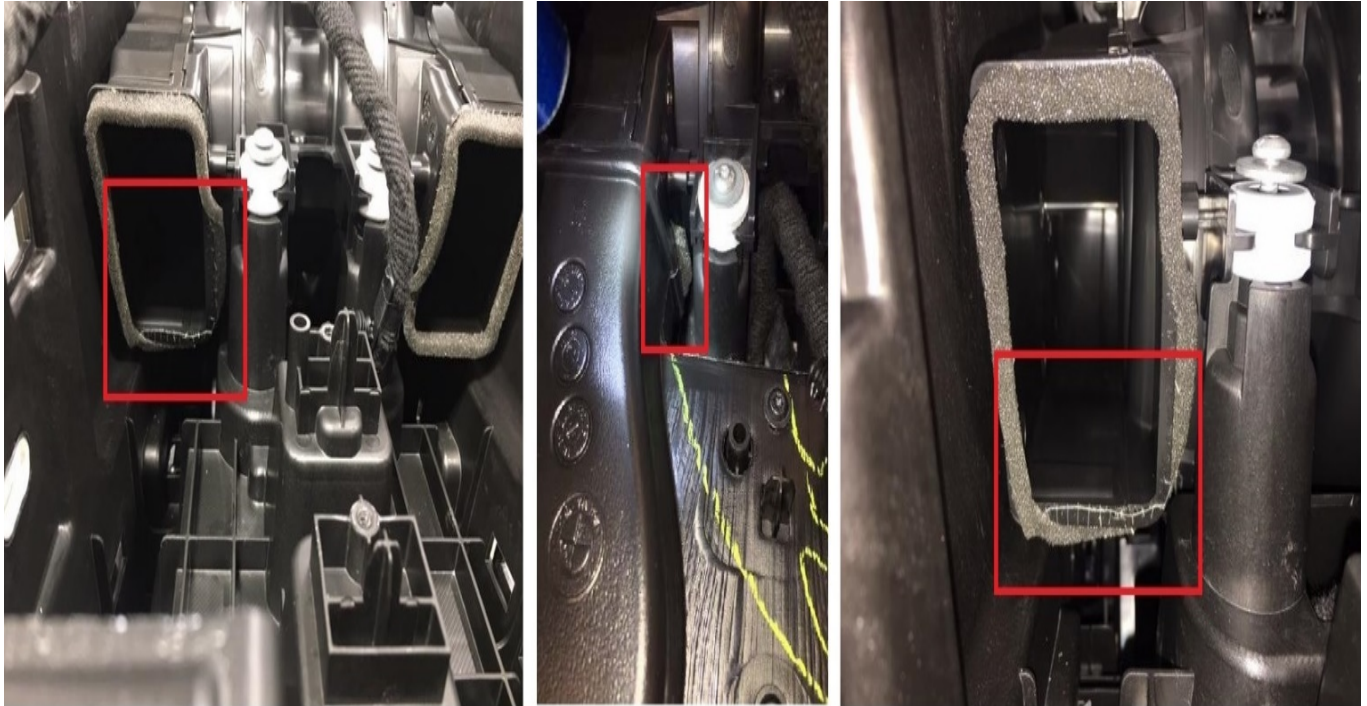
Not OK: Blower Assembly foam insulation found rolled, not positioned in correct, location allowing air to leak.

Not OK: Center duct is not overlapping assembly. Allowing Air to leak.

If one or more air ducts are not properly mounted or connected, disassemble these and install them correctly. Observe point 2 when installing!

2. Check if the foam material to the next connecting piece is correctly installed. If damaged install a locally sourced, one side self-adhesive

HVAC foam. (The foam seal comes assembled on new parts and is not available separately in the BMW parts system).

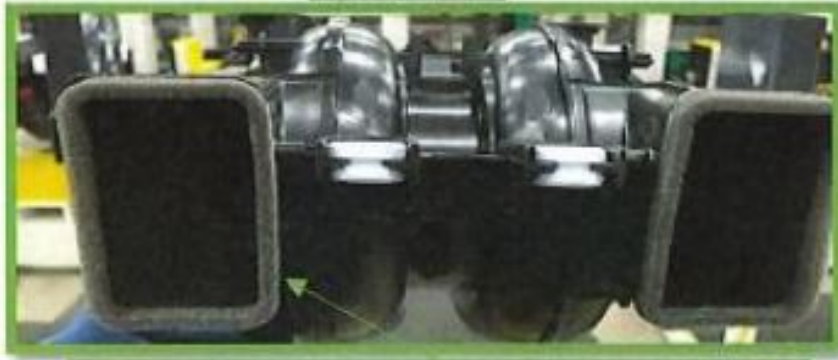
OK: Blower Assy. foam insulation in right position.

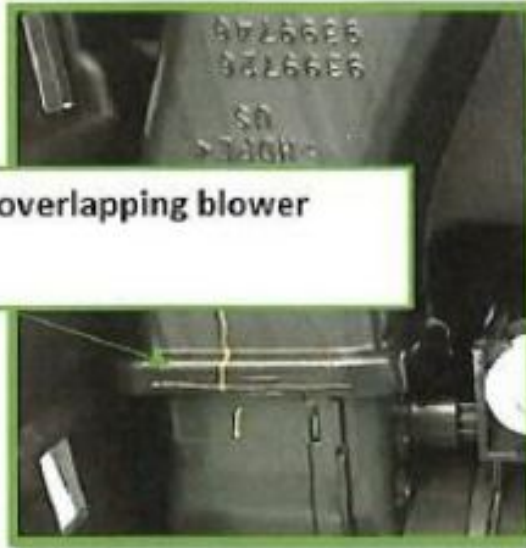
OK: Center duct is overlapping blower assy.

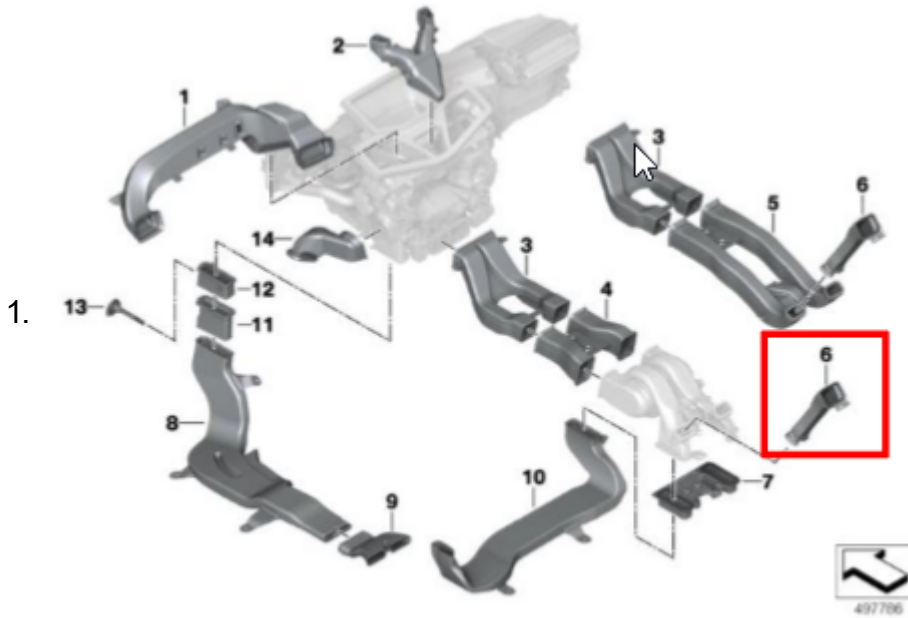
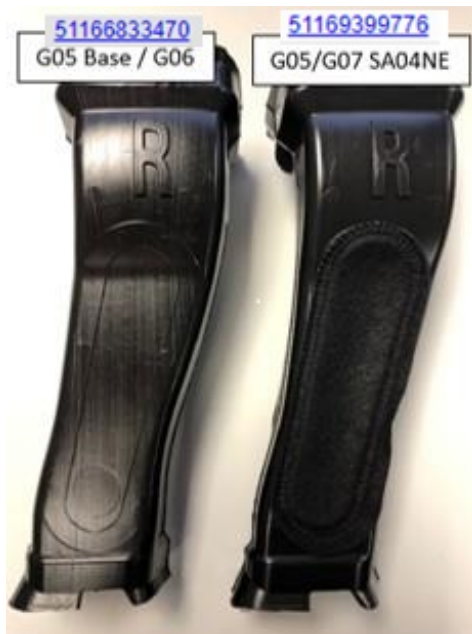
To improve interior acoustic levels and circulate some air into the console, the rear air ducts with part number 51 16 9 399 775 (left side) and 51 16 9 399 776 (right side) are utilized on the G07 and optionally on the G05. These ducts have a hole that is covered in fleece material.

To maximize heat reduction within in the center console, the rear air ducts with part number 51 16 9 399 775 (left) and 51 16 9 399 776 (right) **must be replaced in all cases** with base model rear air ducts with part number 51 16 6 833 469 (left) and 51 16 6 833 470 (right).

NOTE: By installing the base model rear air ducts with part number 51 16 6 833 469 (left side) and 51 19 6 833 470 (right side) these fleece cutouts are removed maximizing the heat reduction in the center console. **The base ducts may impact acoustics of rear HVAC.**
