Business Class M2
Cascadia
108SD/114SD
> New Cascadia

**Freightliner
Service Bulletin**

General Information

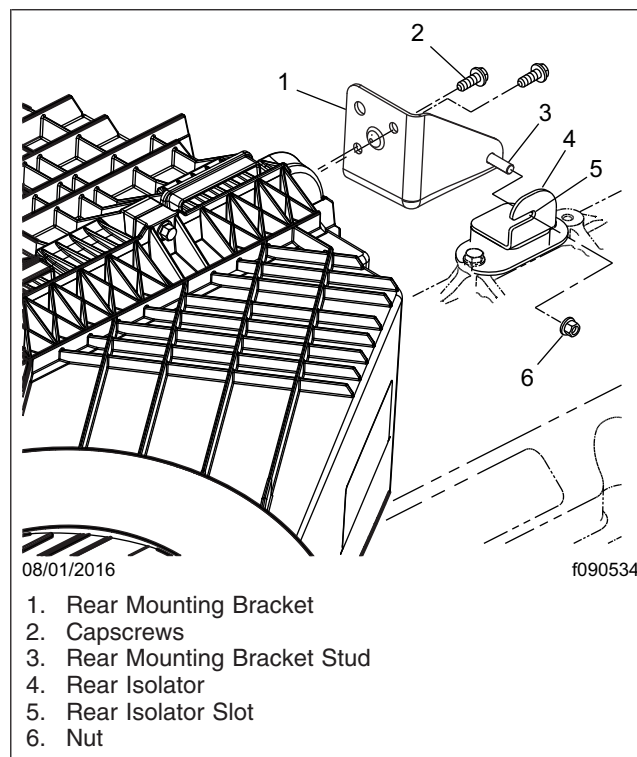
Fig. 1, Air Cleaner Housing Rear Mounting

On New Cascadia vehicles, the air filter housing rear mounting bracket bolts may be found to be loose or missing. If allowed to continue, this can lead to complete bolt failure which will allow the filter housing to rest on and possibly wear through the valve cover. If the filter housing is not properly supported it can also lead to under-hood air being ingested into the engine, possibly generating Detroit air inlet temperature fault codes. To address this issue, the vehicle manufacturing plants have updated their process to add a medium strength liquid thread locker to the fasteners that hold the rear mounting bracket to the filter housing.

If this condition is observed the filter housing support bracket bolts have been running loose. They must be replaced, and the valve cover must be inspected. See the procedure below to replace the air cleaner support bracket bolts.

1. Park the vehicle on a level surface, shut down the engine, and set the parking brake. Chock the tires.
2. Open the hood.
3. Remove the rear mounting bracket stud nut. See [Fig. 1](#).

4. Remove the rear mounting bracket bolts from the housing.
5. Inspect the fasteners for thread damage. If no damage found, apply Loctite® 242 and tighten the rear mounting bracket bolts 13 lbf·ft (18 N·m).
6. Tighten the rear mounting bracekt nut 13 lbf·ft (18 N·m).
