10/15/2020
CAL FTL 32-008

Subject: Drive Axle Leaf Spring Pin Hex Nut Torque Inspection

Models Affected: New Cascadia, Select VINs

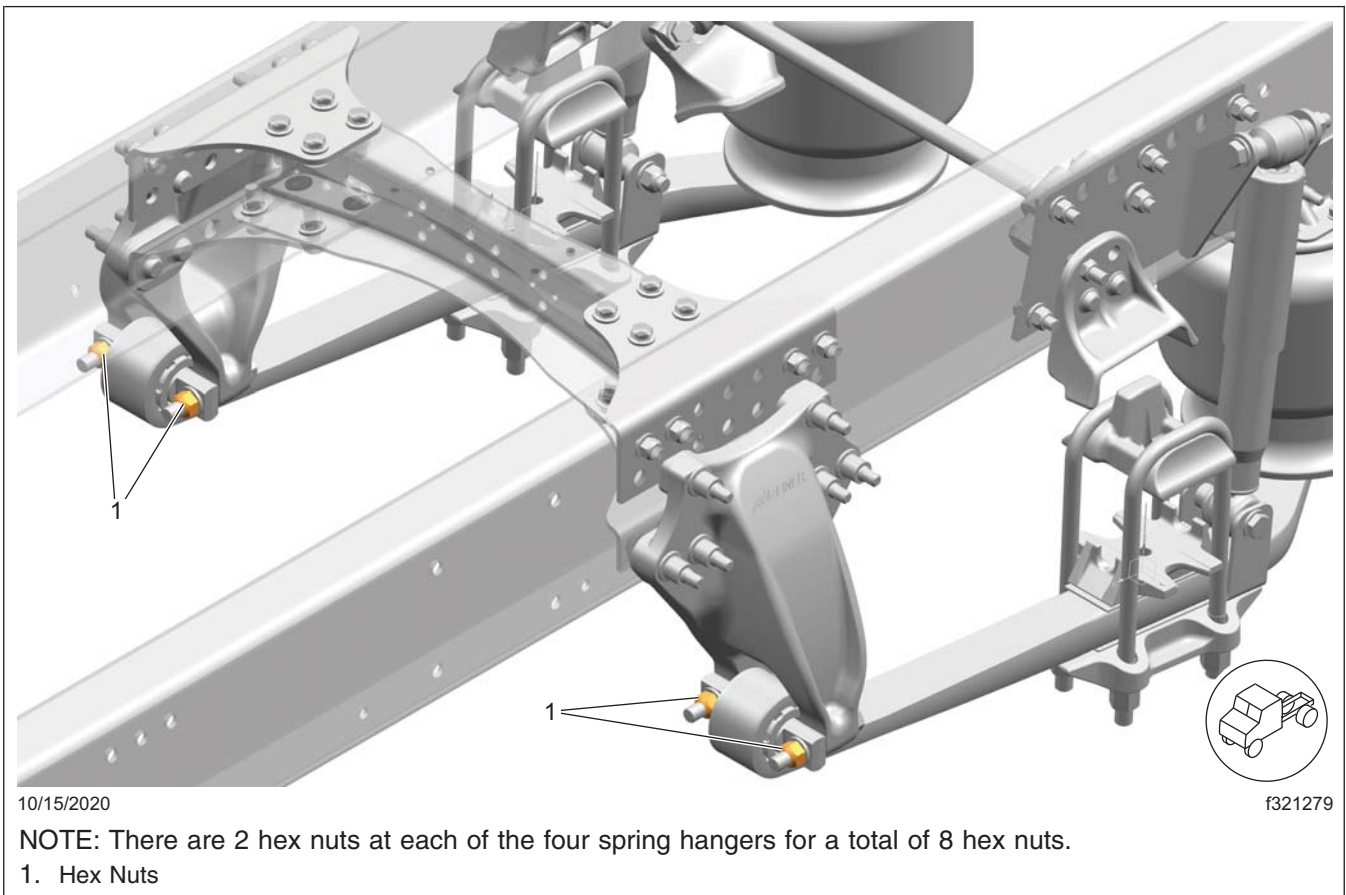
Fig. 1, Drive Axle Leaf Spring Pin Hex Nut Locations

Select New Cascadia vehicles may have been delivered to customers with insufficient torque applied to the hex nuts at the front of the spring hanger. The correct torque for the drive axle leaf spring pin hex nut is 190 to 210 lbf-ft (258 to 285 N·m). See [Fig. 1](#). See the *New Cascadia Workshop Manual* Section 32.01 for more information.

1. Park the vehicle on a level surface, shut down the engine, and set the parking brake. Chock the tires.
2. Set a torque wrench to 190 lbf-ft and apply torque to all 8 hex nuts on the rear suspension.
 - 2.1 If the hex nut is at 190 lbf-ft (259 N·m), no further action is necessary.
 - 2.2 If the hex nut is less than 190 lbf-ft, torque the fastener to 190 to 210 lbf-ft (258 to 285 N·m).

- 2.3 If the hex nut cannot be torqued to 190 lbf-ft (259 N·m), replace the hex nut.
3. Send documentation of vehicles with loose fasteners to your District Service Manager.
