68 Glove box door binding during open/close

68 20 25 2060899/1 October 7, 2020.

Model(s)	Year	VIN Range	Vehicle-Specific Equipment
Q5	2019 - 2020	All	Not Applicable

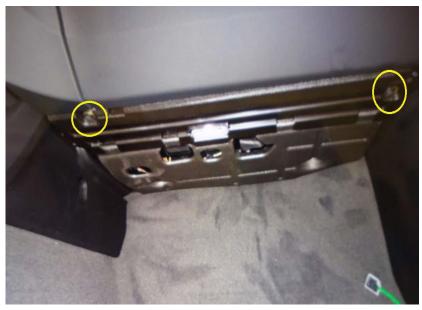
Figure 1. Both lower glove box bolts.

1. Loosen both lower glove box bolts (Figure 1).

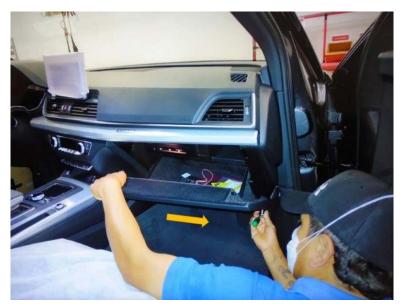
Figure 2. Adjusting the glove box to increase clearances.

While pulling the glove box door outward in direction of the A-Pillar, tighten both lower glove box bolts according to the repair manuals in ElsaPro Figure 2).

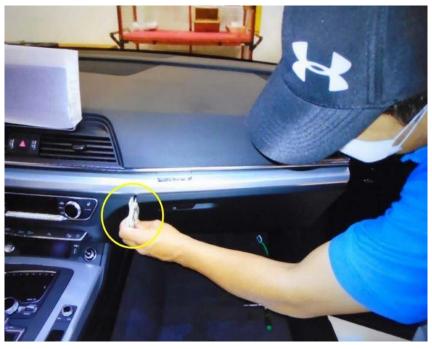
Figure 3. Checking the gap between the glove box door and the center console.

Check the gap between the center console and the glove box door to ensure adequate clearance (Figure 3).
