72 Noises from the second row seats

72 20 29 2060719/1 October 5, 2020.

Model(s)	Year	VIN Range	Vehicle-Specific Equipment
Q7, SQ7	2017 - 2022	All	Not Applicable

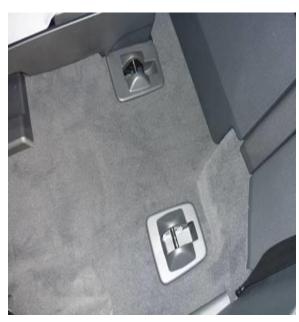
Figure 3. Outer and inner locking plate with trim installed.

2. Remove the trim of the outer locking plate (door side) by following the repair manuals in Elsa (Figures 3 - 4).

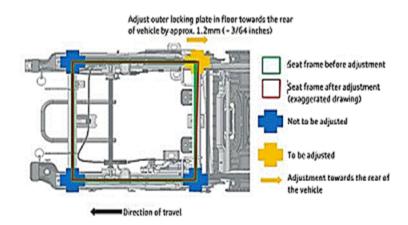
Figure 6. Adjustment of outer locking plate.

Loosen both bolts of the locking plate and then move the locking plate evenly towards the rear of the vehicle by approximately 1.2mm (~ 3/64 inches) (Figures 5 - 6).

Tip: Mark the location of the locking plate prior to loosening the bolts.
