01-18-13 - MIL ON DTC P0401 Exhaust Gas Recirculation Flow Insufficient

Release date: 10/1/2020

Condition

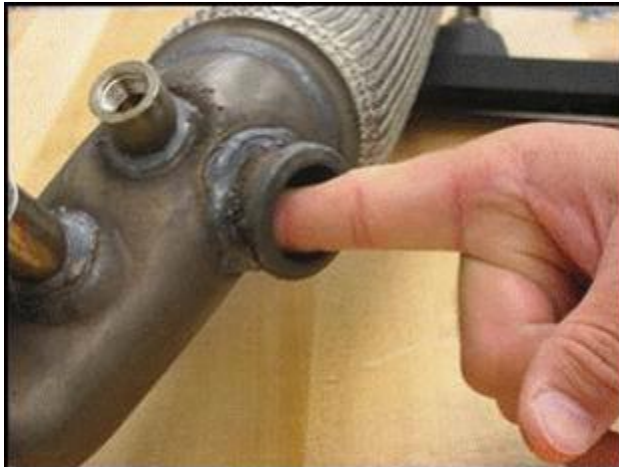
Figure 1

High soot loads prior to regeneration can cause possible restrictions in the EGR filter.

- Remove the EGR filter from the DPF and swipe the inside of the exhaust pipe at the EGR filter connection point using a clean cloth or your finger. See figures 1 and 2 below.

If your finger or the cloth comes out with black soot, replace the DPF & EGR filter together.

When replacing the DPF for the fault P0401 it is important to replace both the DPF and the EGR filter together, as soot accumulation in the EGR filter is undesired. It is NOT necessary to replace any other components for this fault (i.e. NOx Storage Catalyst, Sulfur Catalyst, Exhaust Flap, EGR Cooler). These components should be reinstalled in the vehicle with the new DPF and EGR filter.
