Technical Service Bulletin

91 MIB2+: lower display flickering after a software update

91 20 18 2061029/1 October 15, 2020.

Model(s)	Year	VIN Range	Vehicle-Specific Equipment
A6 allroad, A6 Avant, RS6 Avant, and RS7	2020	All	MIB2+
A6, A7, S6, and S7	2019 - 2020	All	MIB2+

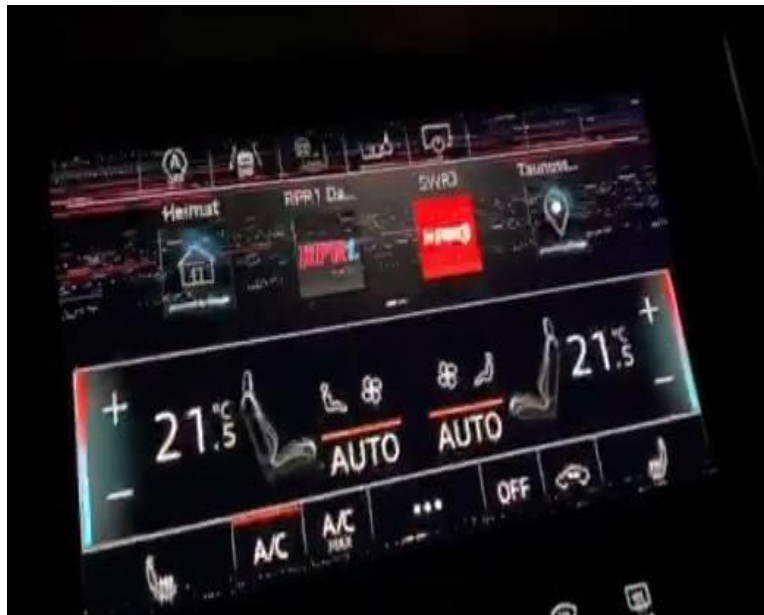
- After a MMI Software update has been completed, the lower display sporadically flickers (Figure 1).

Figure 1. The display sporadically flickers.

There are compatibility issue between the display and MMI software.

- Update the MIB2+ display using either Method 1 or Method 2 according to TSB 2056558: *91 MIB2+ Software Update Instructions* and use SVM code 636S002.
