STAR ONLINE PUBLICATION

Case Number: S2018000007

Symptom/Vehicle Issue: (Revision A) Diagnostic Trouble Code (DTC) P0299 – Turbocharger Underboost Additional Diagnostics

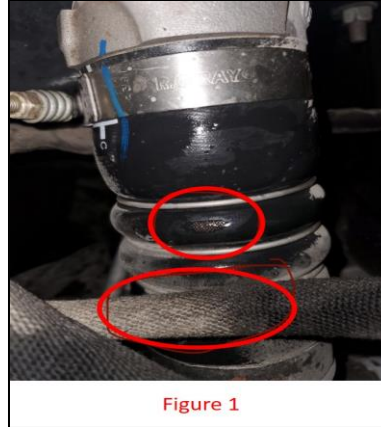
1. Remove, and inspect the engine air filter. Ensure that the air filter is clean, and is an OEM replacement. Several reports have been received from the field of some aftermarket replacement air filters causing this DTC to set. These filters may look very similar to filters available through Mopar. If the filter is an aftermarket filter, swap the filter with the proper Mopar replacement, and retest the DTC.
2. Ensure that the Charge Air Cooler (CAC) system is properly pressure tested per the steps outlined in Service Library Service Information Section 09 – Engine, 6.7L Diesel > Turbocharger System > Diagnosis and Testing – Leaks. While performing the CAC leak testing, pay close attention to the CAC boot connected to the turbo outlet for leaks caused by the wire harness rubbing through the boot. Please see ([Figure 1](#)).

3. If the boot is found damaged, replace as necessary, and retest the CAC system for any additional leaks. Repair as necessary.
4. Remove the EGR Crossover tube from the EGR valve, and inspect the EGR inlet to see if there are signs that the valve internal seat has begun to rotate. Please see (Figure 2). The EGR internal shaft should be completely visible when looking into the crossover tube inlet.

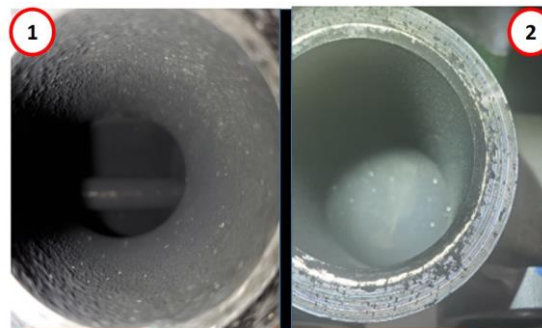
Figure 2

1. Healthy part
2. EGR with rotated seat

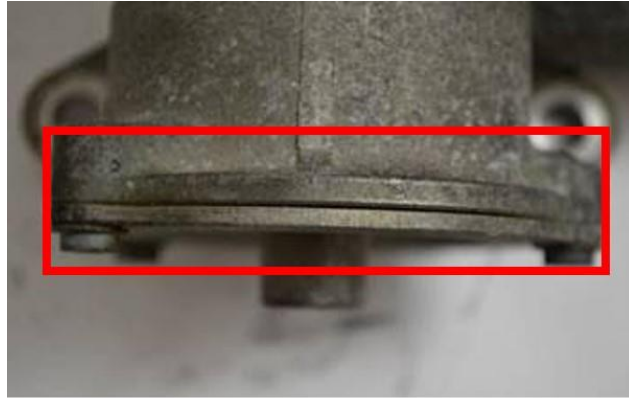
Figure 3.

5. Thoroughly inspect the EGR valve end cap for signs of leaks (**Figure 3**). If found to be leaking, replace the EGR valve.
