STAR ONLINE PUBLICATION

Case Number: S2021000003 - REV. A.

Symptom/Vehicle Issue: (CEL) Check Engine Light Is On, Vehicle Speed May Be Limited (2nd Gear Limp Mode), Shifting May Be Erratic, Cluster Message To Service Transmission

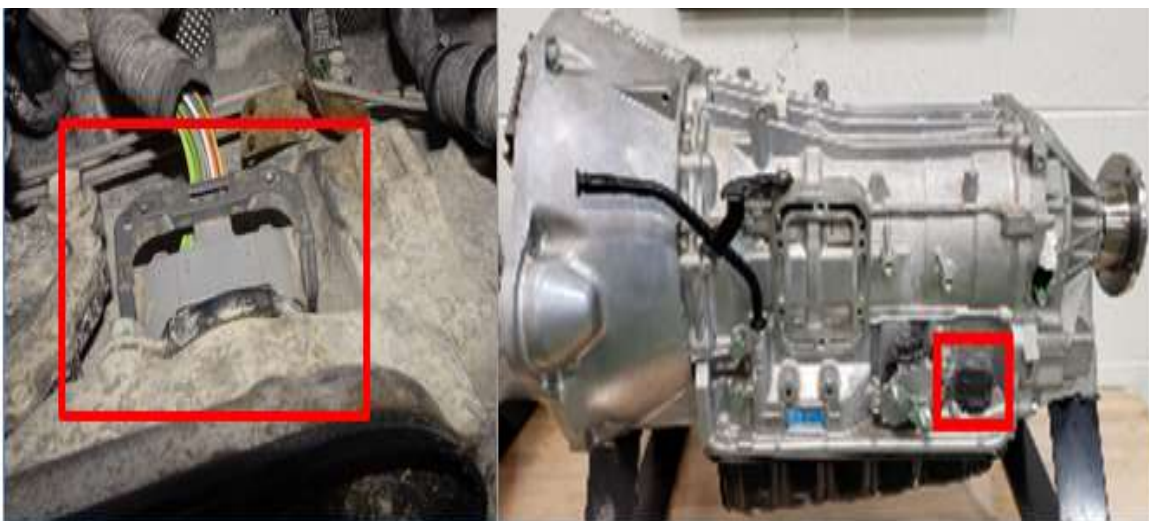
Fig 1-1

Repair Procedure: Inspect the transmission housing main connector on the left side of the transmission housing. Connector D6647 is located toward at the rear of the transmission case as shown. Inspect the connector for any signs of loose or pushed out terminals or poorly secured connection Fig 1, 2, 3.

Clean, repair or replace any affected transmission case connectors using the FCA approved connector and circuit repair guidelines. Secure any pushed out terminals or weather seals to ensure no water entry. If no transmission case connector or terminal damage is located at the transmission case connector, inspect the inline harness connector XY107A – 34-way black connector at the location shown below for any potential suspect circuit terminal issues and repair as needed. Connector repair kit - 68228245AA

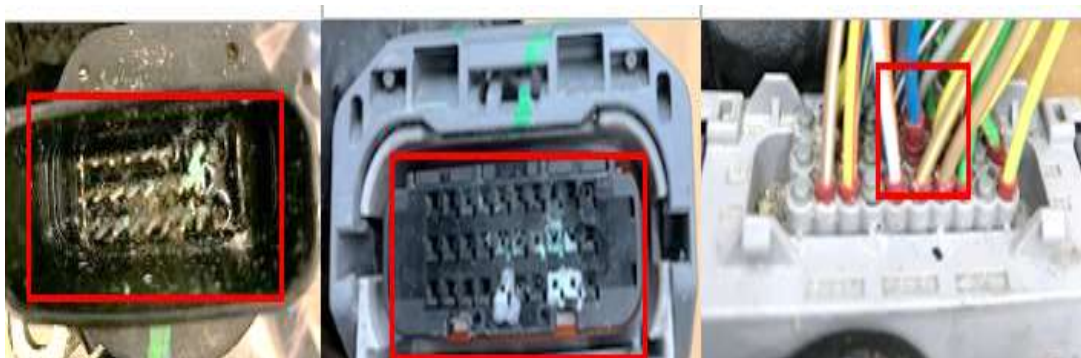
Fig 2

Transmission case connectors
