STAR ONLINE PUBLICATION

Case Number: S1913000001 Rev A.

Symptom/Vehicle Issue: Front Bumper Fascia is misaligned or popping out

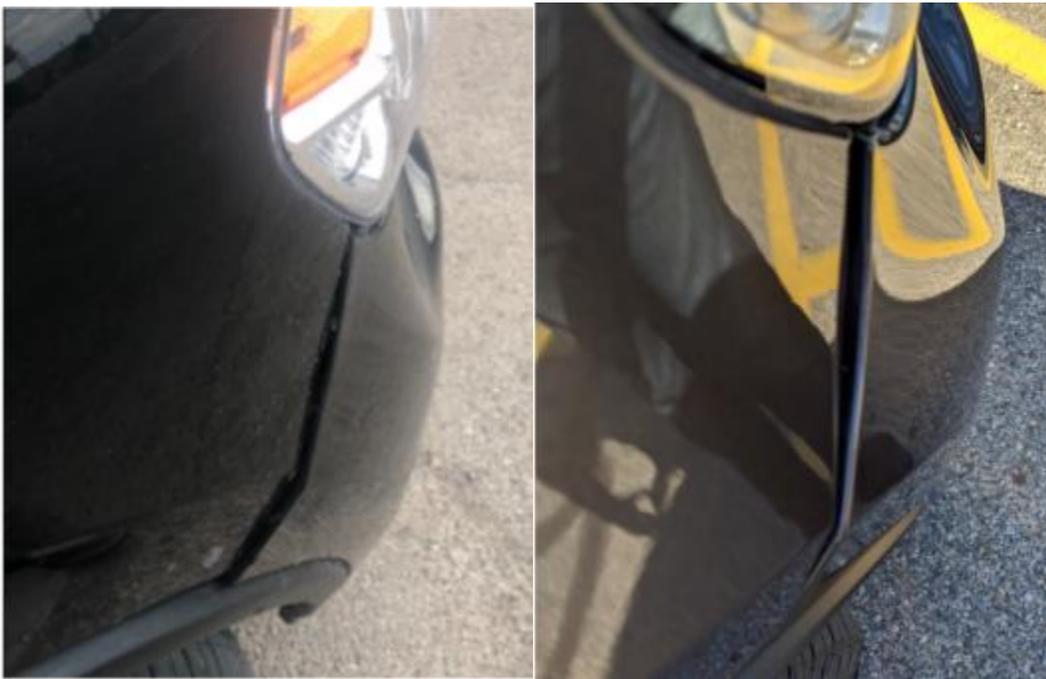
Fig 1

Discussion: Compare images below to customer vehicle. If the condition below exists, proceed to the steps below.
