UPDATE FROM WARRANTY OPERATIONS

WARRANTY OPERATIONS NEWSLETTER VOLUME 6, ISSUE 8

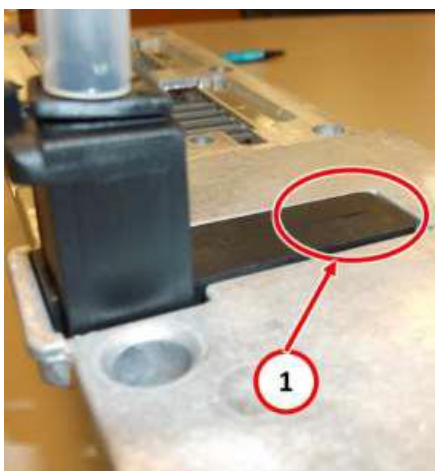
Inspect the grid heater power terminal located on the intake manifold cover for the plastic over-mold being deformed as well as the power feed cable for signs of terminal sealant flow from the terminal sleeve (See Figure 1 and 2).

Good part. No deformation

If any of the above conditions are found, replace the intake grid heater assembly and grid heater relay as a set.

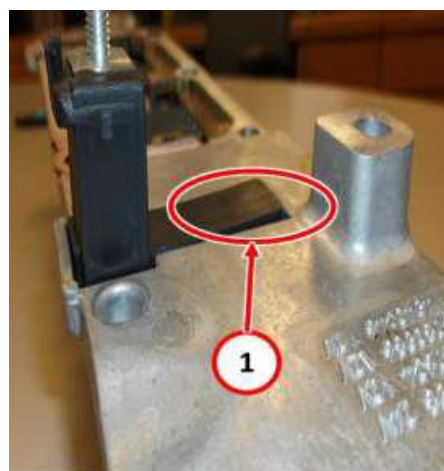
Figure 2

Failed part. Slight lifting of plastic

It is important to determine the root cause of the failure, since it may have been caused by either the grid heater or the grid heater relay.

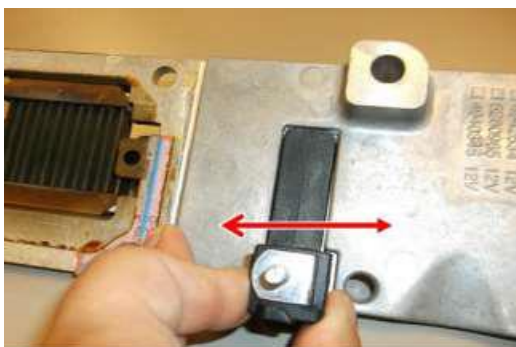
Figure 3

Check to see if the grid heater power terminal can be moved by hand (See Figure 3).

There should be NO movement of the terminal back and forth.

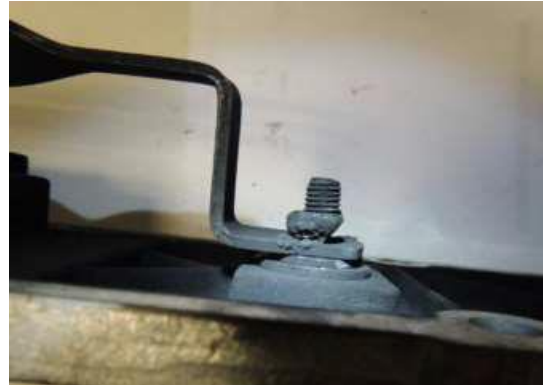
Figure 4

Remove the grid heater assembly and inspect the bolt on the bus bar for signs of arcing and damage. See (Figure 4)

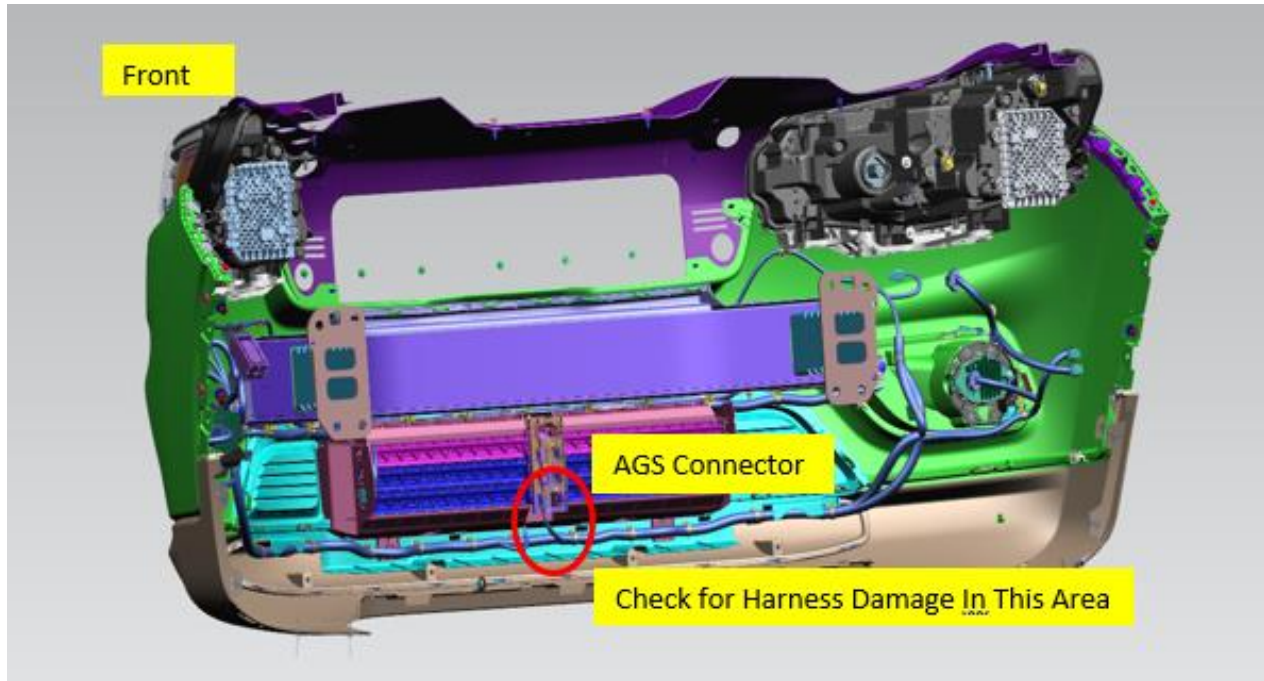
When the Malfunction Indicator Lamp (MIL) is on and AGS DTC U11E9 - Loss Communication with AGS is active or stored, inspect the wiring harness for signs of damage (nicks or cuts in the wires). If the wiring harness is damaged, do not automatically replace the AGS. Use wiring kit 68396618AA to repair the harness or replace the fascia harness as necessary. Disconnect the AGS to wiring harness connector and inspect for

corrosion. If corrosion is present in the AGS connector, replace the AGS.

Reference this diagram and photo of the 2019 Cherokee (KL) fascia wiring harness location and damage.

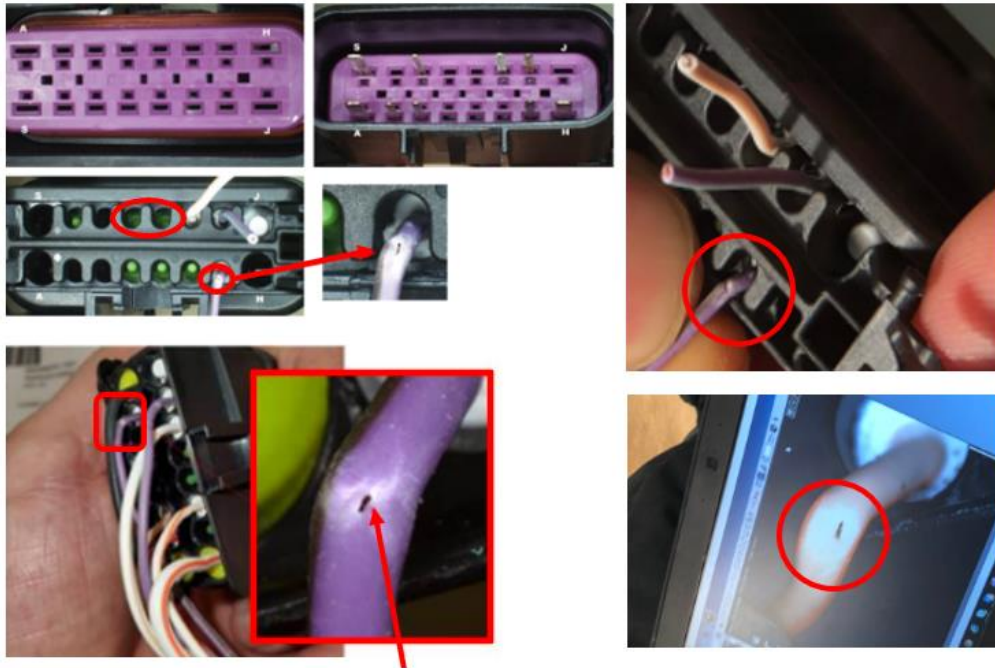
16-way Dash and Fascia Harness Connectors (Nicks/Cuts):

1. If the conditions below are present, use connector kit 68497543AA to repair the 16-way dash side connector and replace the fascia harness (a connector repair kit is not available).
 - Damage (nicks/cuts in the wires) at either 16-way connector. The damage may be very small and difficult to see with the naked eye.
 - Corrosion or moisture in either 16-way connector.

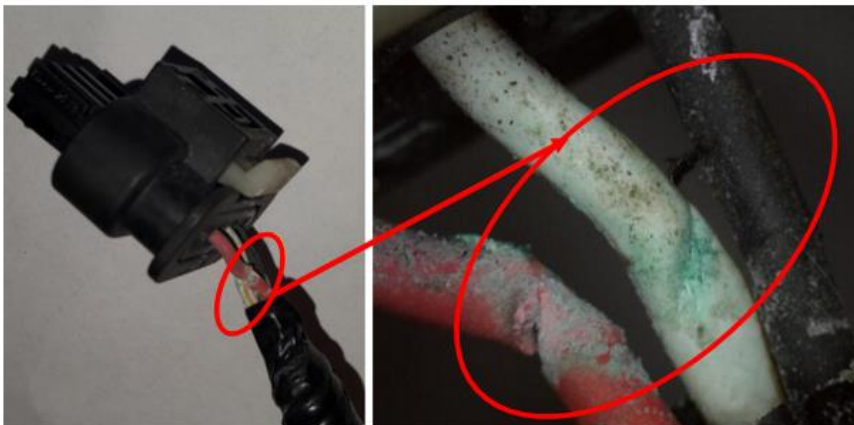
Fascia Harness Connector @ AGS Connection:

2. Disconnect the AGS/fascia connectors and inspect for corrosion. If corrosion is present in the fascia connector, repair it using connector kit 68396618AB or replace the harness as necessary.
3. If corrosion is present in the AGS connector, replace the AGS.
4. Do not add grease to the AGS/fascia connectors.

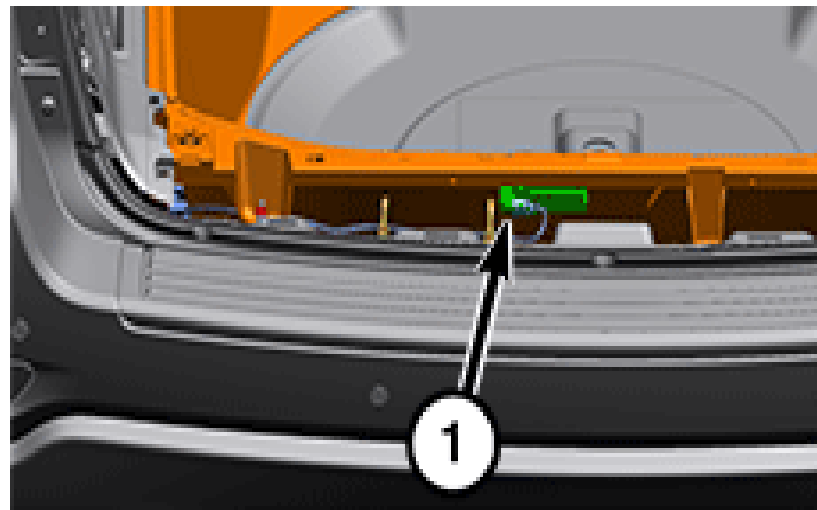
A Low Frequency (LF) Antenna is attached to the Durango and Grand Cherokee rear cargo load floor under the rear scuff plate. In order to remove the load floor, the antenna connector must be disconnected prior to pulling up on the load floor. If this is not disconnected, the LF antenna electrical connector will likely break.

The LF antenna electrical connector (item 1 below) is shown attached to the back of the load floor bin.

CAUTION: Failure to disconnect the wire harness connector from the antenna on the rear of the cargo load floor bin, prior to removal of the load floor bin, will result in damage to the antenna, antenna mounting, or wire harness. Damage caused by failure to follow this procedure is not a warrantable repair.

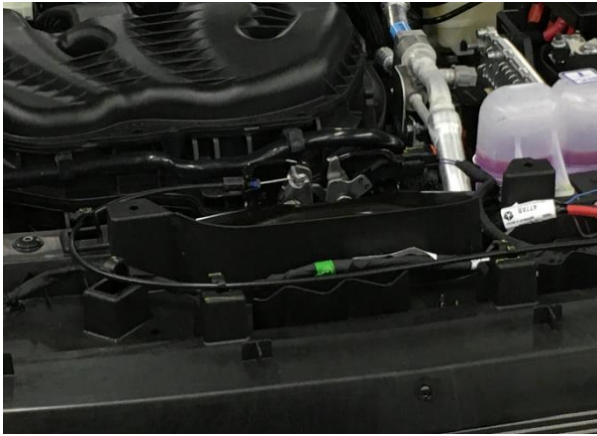
Hood Latch

On November 26, 2019, a change was made to the latch position during assembly to mitigate hood flutter. This change caused the closing effort to increase slightly. Do not move or reset the hood latch, or the six hood bumpers due to closing effort concerns, unless specified by the customer.
