NUMBER: 08-048-20 REV. A

DATE: September 1, 2020

UAX, UCX, UAV and UCV Radio Over the Air Software Version Updates

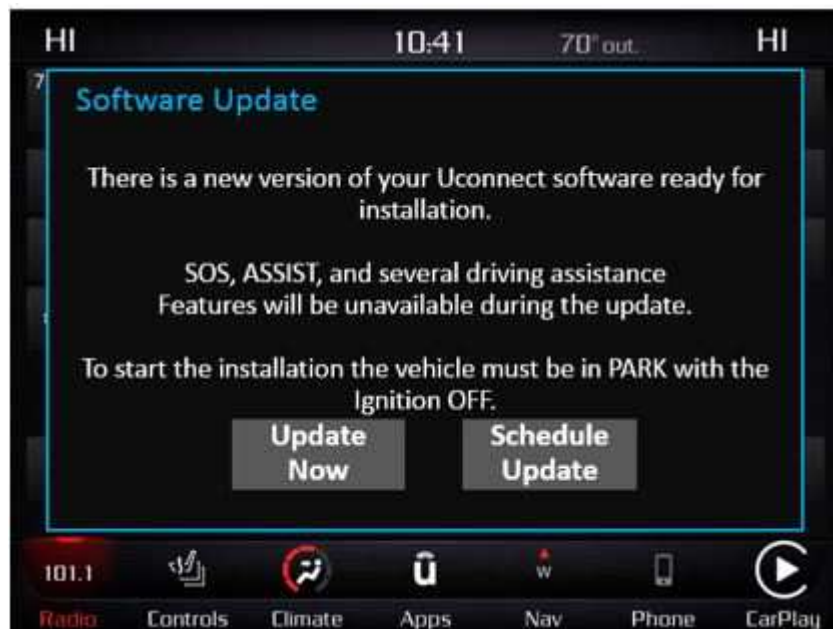
Fig. 1

Customers will see a notification on their radio screen when new software is available for their radio (Fig. 1) . The owner will have the option to update the radio or schedule the update for later. **There is not an option to decline the update indefinitely, the update must be performed.**

Software Acceptance Screen

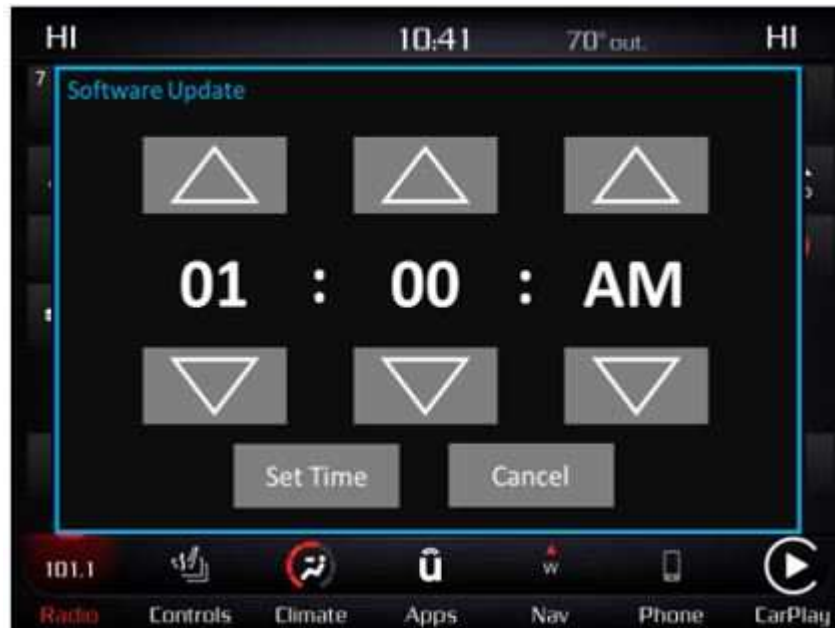
Fig. 2

NOTE: If selecting “Schedule Update” the screen below will be displayed. The customer can select the exact time they want the update to begin (Fig. 2) .

Schedule Update Screen

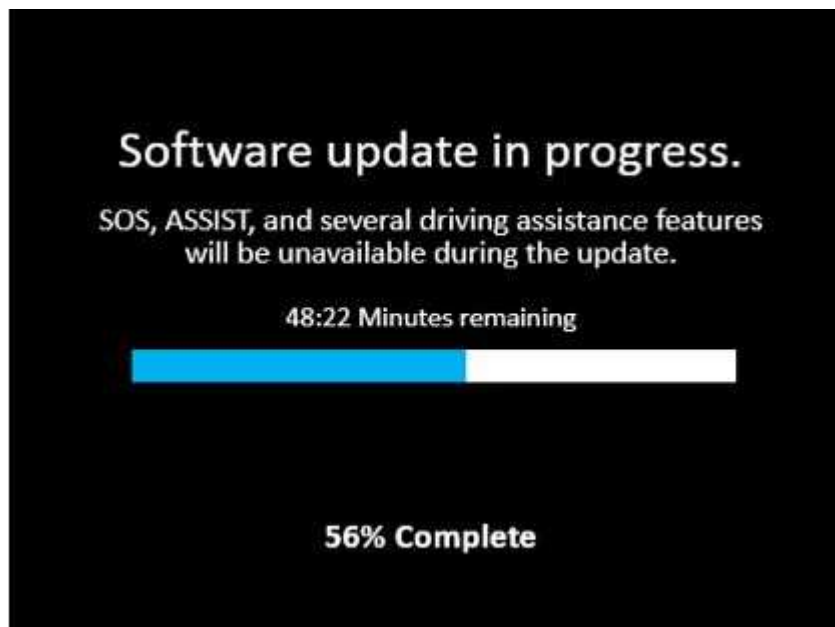
Fig. 3

1. The vehicle transmission needs to be in the park position, or have the vehicle in neutral with parking brake engaged if equipped with a manual transmission. The ignition needs to be off.
2. Whether the customer selects “Update Now” or “Schedule Update” (Fig. 2) and sets a time, they can shut off the vehicle and leave. The update will be completed automatically (Fig. 3) .

Update In Progress Screen
